# NAFLIC

TECHNICAL BULLETIN — October 2015

## **401. Zamperla Jump Around bolt failure and lower radial arm cracking**

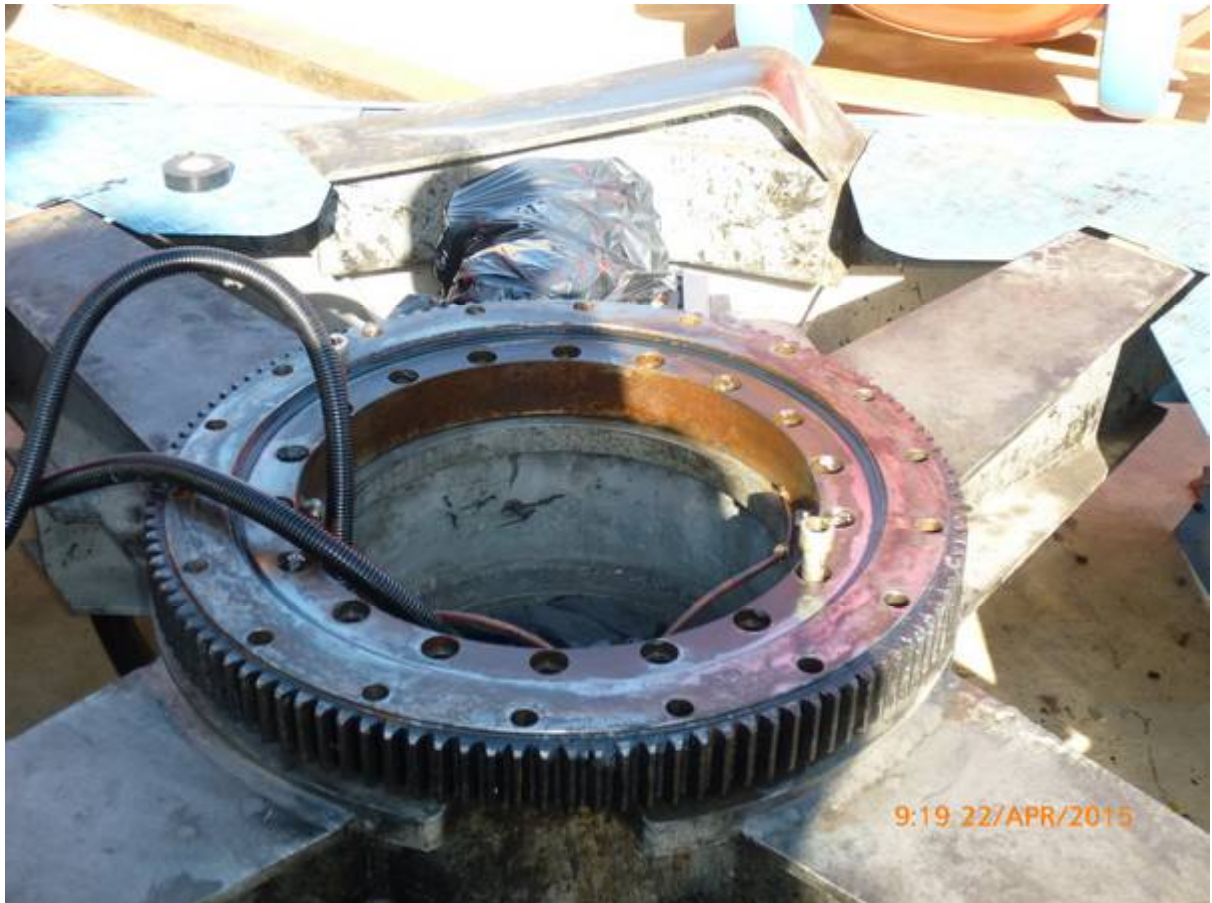
Problems have also been reported regarding the slewing ring bolts. The slewing ring has two rings of bolts. During inspection of the device a number of bolts on the inner ring were found to have completely or partially failed. See photo(s) below. Note that these bolts are not accessible for inspection without stripping down the device.

Controllers and inspection bodies are urged to pay particularly close attention to these known problem areas.
