Worldwide Safety Group Inc.

To all owners of KMG Freak Out Rides,

It has come to our attention that a 2004 KMG Freak Out ride has had a sweep attachment bracket break off from the center hub during disassembly of the ride.

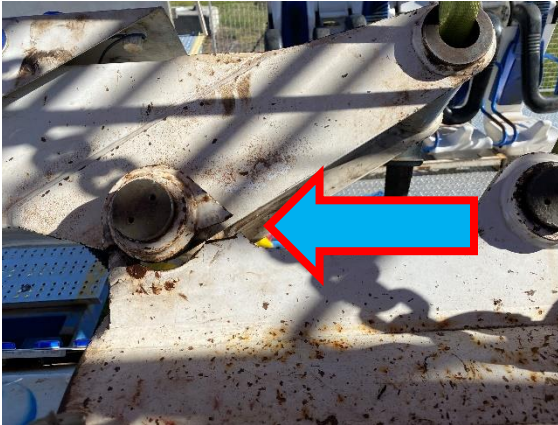
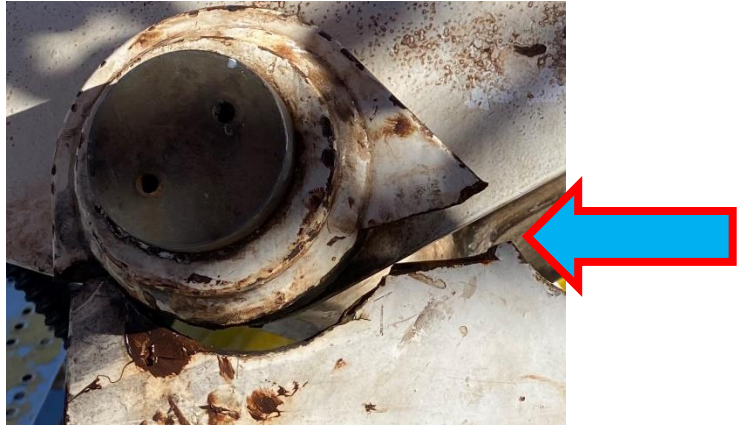
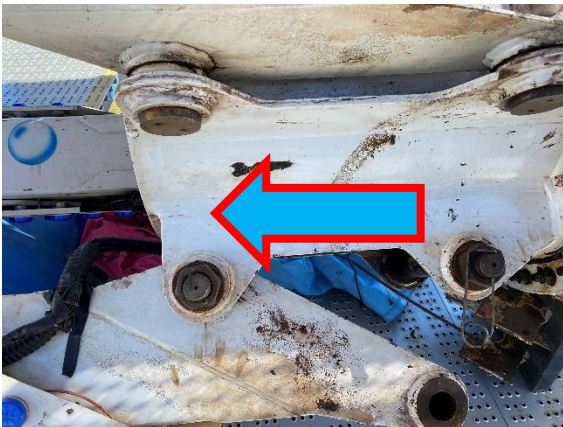
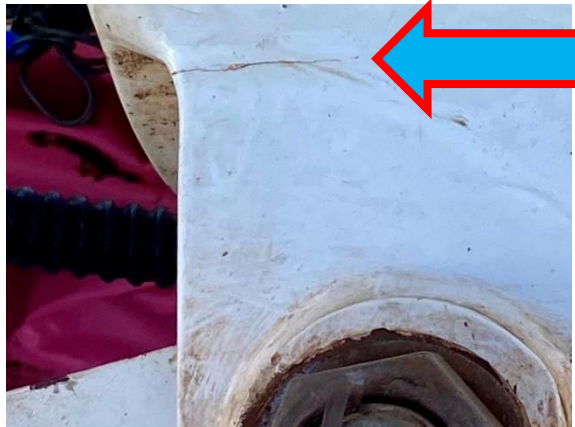
Please see the pictures below for the areas of concern this is the lower attachment area of the sweeps to the center hub.

We encourage all owners / operators to have your ride inspected by a qualified individual to look for indications and if any are found to have additional nondestructive testing performed to verify the findings.

If indications are found, please do not operate the ride and contact the manufacturer for instructions.
