SERVICE BULLETIN QUA/03/001

(QUASAR AMUSEMENT RIDE)

SEPTEMBER 1988

MFG: A.R.M. (UK) LTD.
NAME: QUASAR
TYPE: NON-KIDNIE

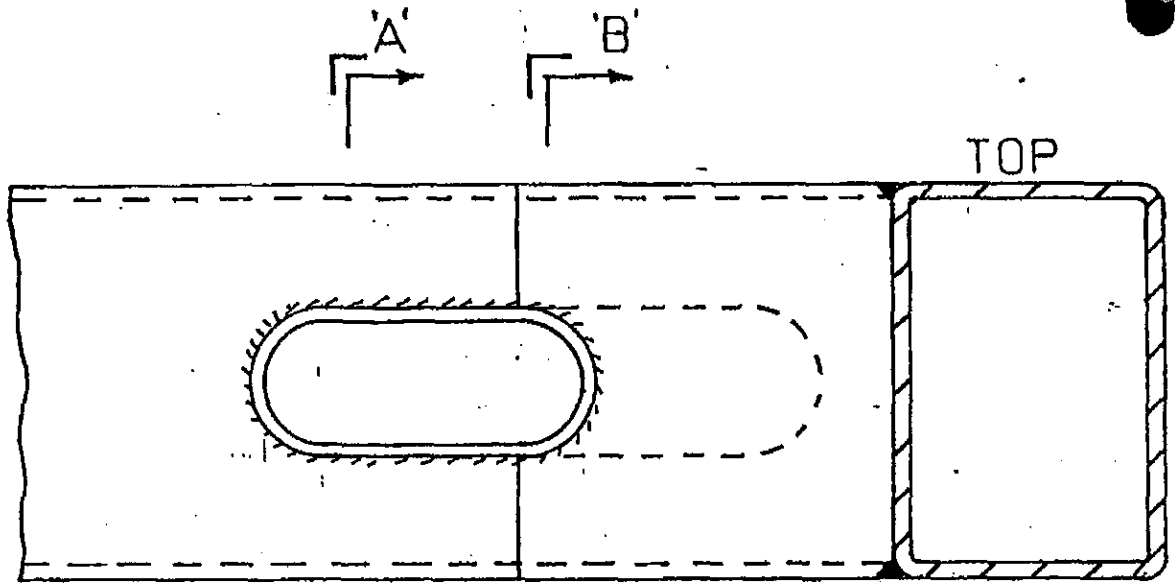
MODIFIED PIPE SLOT

1. Bracing gussets to connect side members, crossmembers and lower plate. This will reduce moment arm on sidemembers and increase torsional stiffness, thus reducing stress levels and stress range in this vicinity.
2. Stiffening plate on underside to lower neutral axis and increase section modulus on tensile flange of sidemembers in the XX plane. This will also increase torsional stiffness and bending stiffness in the YY plane.
3. Modification to the profile of pipe slot in forward crossmember by radiusing the ends of slot, thus removing the local stress concentration present at the upper square corners of the original slot.

2. Repair any existing cracks in crossmember located at the top corners of pipe slot by drilling a 10mm diameter hole at the upper end of cracks as depicted on page 6. No further action is required.
3. Modify shape of pipe slot as depicted on page 6. Remove any drag lines from flame cutting and grind smooth.
Weld pipe slot flange part no. QUA/01/4 into position as depicted on pages 7 and 8.
4. Weld lower stiffening plate into position. Weld type as depicted on pages 11 and 12.
5. Weld gussets in the vicinity of pipe slot into position, part no. QUA/01/2 and QUA/01/3. Weld joint type and corner detail as depicted on pages 5 and 12. Weld remainder of gussets in position. Part No. QUA/01/1.
6. The weld connecting the sideplates to the top of sidemembers is to be ground flush with top surface of sidemembers for the last 150mm of its length. See pages 10 and 12.
