**Bulletin #** SR-5K-810

## SERVICE BULLETIN

Ride Name: Cliff Hanger

**Abstract of Issue:** The following is a procedure for upgrading hardware on the pivot pins of the upper and lower hanger blocks.

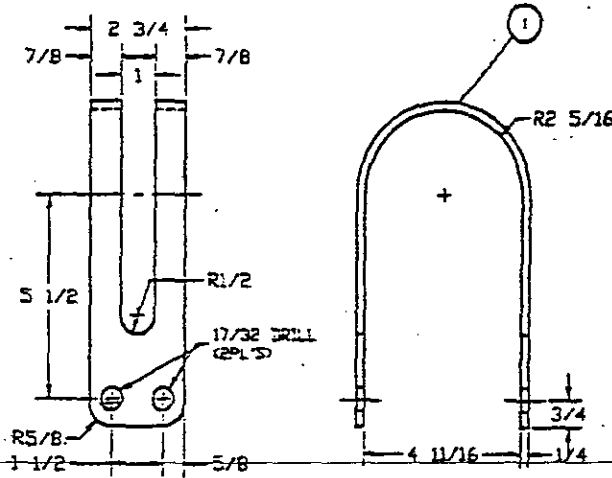
SAFETY LOOP FOR UPPER HANGER BLOCK

10 REQ'D PER RIDE

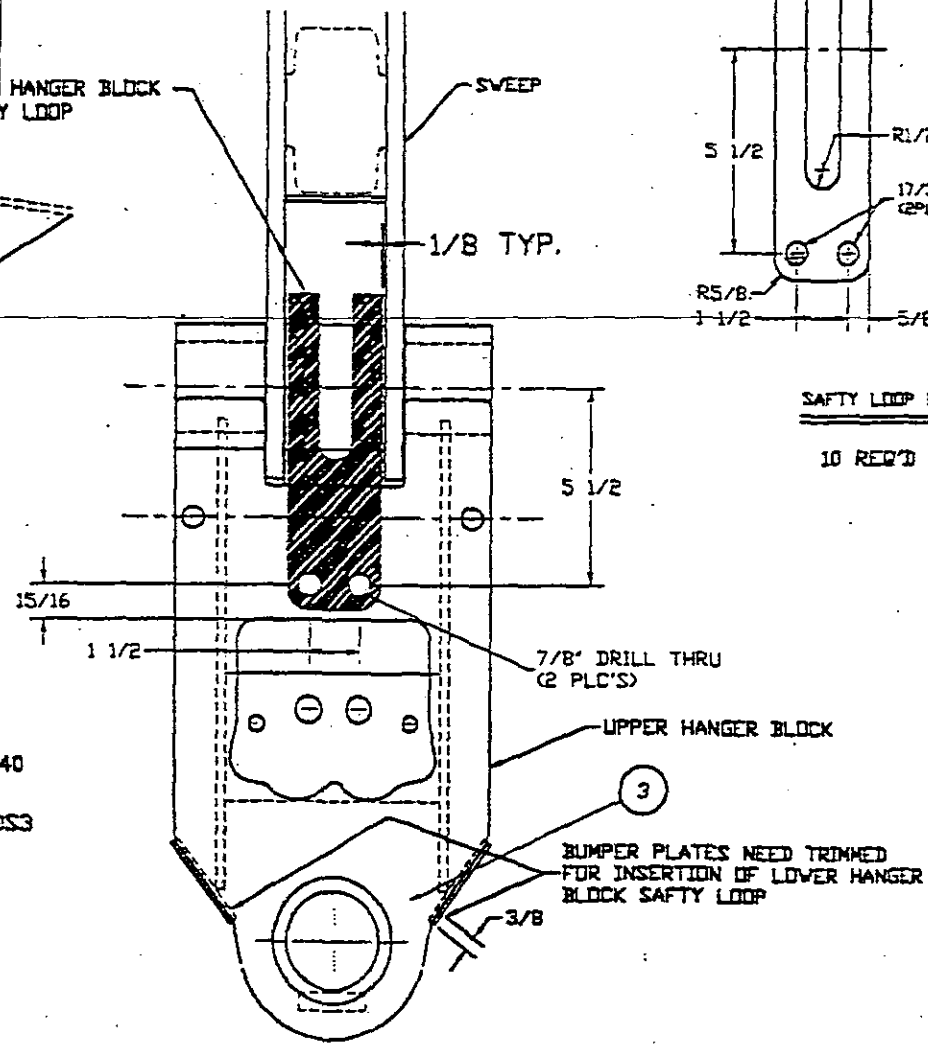
BUMPER PLATES NEED TRIMMED  
FOR INSERTION OF LOWER HANGER  
BLOCK SAFETY LOOP

WELD 1/2" SCH. 40  
PIPE (2 PLC'S)  
USE 7018 DR E70S3

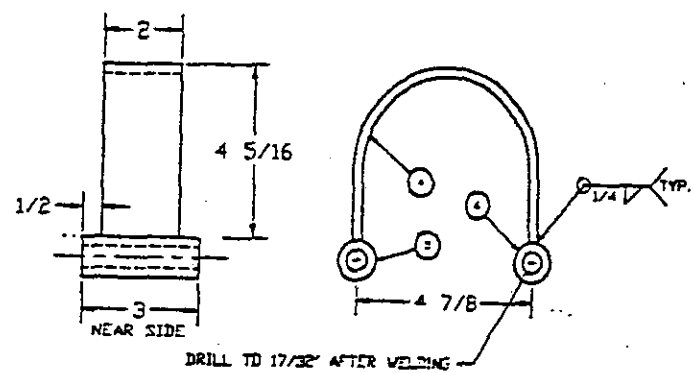
SAFETY LOOP FOR UPPER HANGER BLOCK

LOWER SAFETY LOOP MUST BE INSERTED THROUGH THE UPPER HANGER BLOCK BEFORE ASSEMBLY.

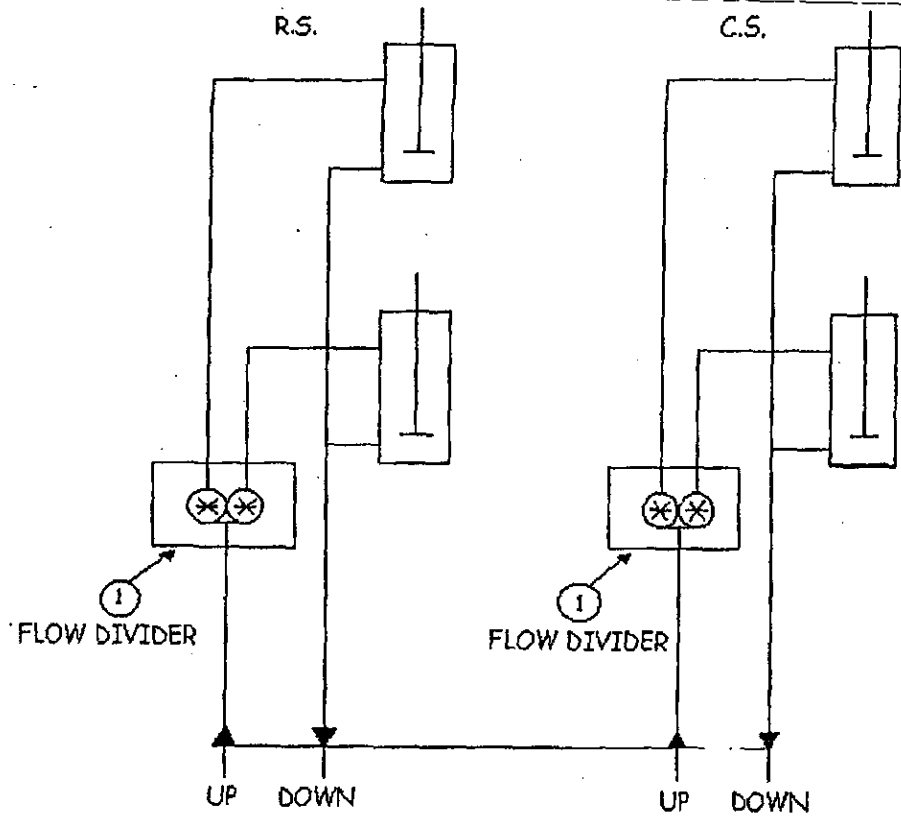
FLOW DIVIDER  
HYDRAULIC SCHEMATIC

Dartron has determined that the two cylinders that raise and lower the car storage storage racks on either the curb or drivers side could move at different speeds. If the rack operator continues the rack movement the rack could twist resulting in the rack rotation shaft being pulled out of the pillow block or the pillow block fracturing. Either situation could cause the cars to fall to the ground.

**Step 5:** Remove all three hoses from this bulkhead tee fitting and replace the tee in the trailer with the straight fitting from the kit.

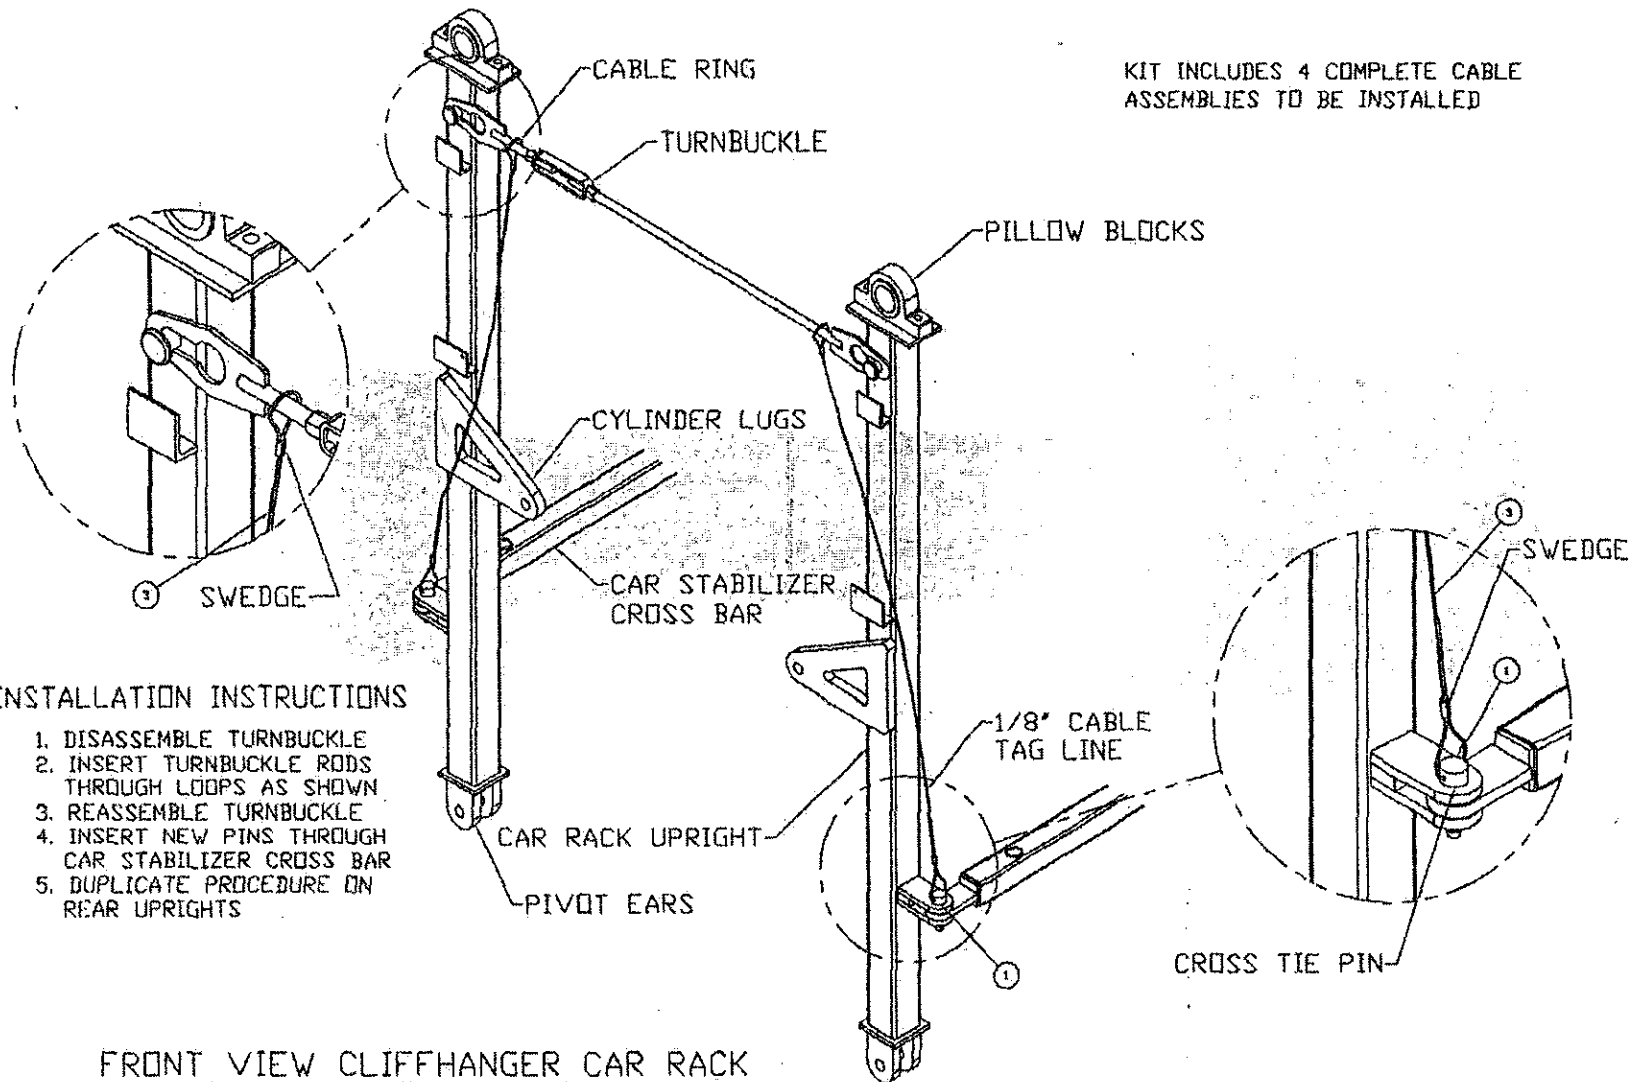
KIT INCLUDES 4 COMPLETE CABLE ASSEMBLIES TO BE INSTALLED

**Abstract of Issue:** Dartron is aware that some Cliff Hanger operators have experienced bent car Hanger Stems. Bent stems can result from lowering the car transport rack without removing pins that attach the Car Stabilizer Cross Tube to the car transport rack. See Page 2 of this Bulletin. Using the damaged stems can result in a failure of the stem and possibly injury to guests.

1. DISASSEMBLE TURNBUCKLE
2. INSERT TURNBUCKLE RODS THROUGH LOOPS AS SHOWN
3. REASSEMBLE TURNBUCKLE
4. INSERT NEW PINS THROUGH CAR STABILIZER CROSS BAR
5. DUPLICATE PROCEDURE ON REAR UPRIGHTS

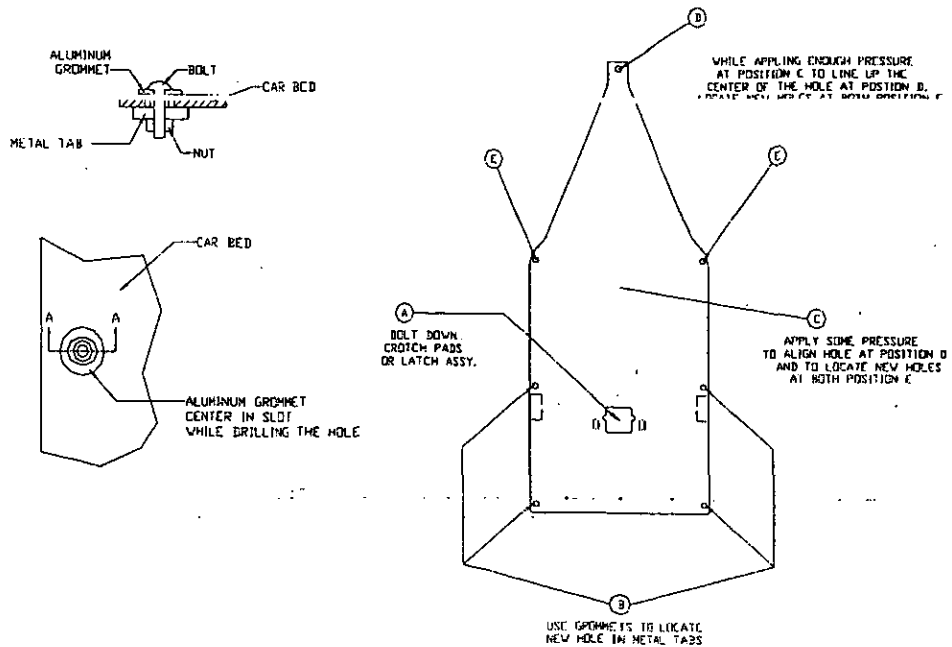
**Reason for release:** A new version of car beds is now available that addresses the breakage problems by allowing the car bed fasteners to float in the car bed holes to accommodate heavier loads and thermal expansion. Additionally, there will only be a single replacement bed that can be used for any of the three positions. The car bed will have 'cut-out' making it usable in either the inside, outside or center locations.

1. Determine which cutout will need to be removed to give you the proper configuration for the car bed being replaced.
  - a. For the center car bed, drill the holes at the end of the slots beside the latch assembly with a 5/8" drill. A 1/16" pilot hole is provided.
  - b. For the left and right car beds, determine which side cutout will need the clearance for the pivot point and remove the corresponding notch at the perforations.
2. Place the passenger carrier bed into the approximate location on the car bed frame.
3. At position A; bolt down the crotch pad on the side beds or the latch assembly on the center, depending on which one is being replaced; as illustrated on the attached sheet. Use this to align the holes.

11. Re-install the car bed using the grommets to fasten the bed down. **DO NOT OVERTIGHTEN**, it will mash the aluminum insert and not let the bed 'float'.

12. See following drawing/diagram.
