WOL	12/20/2008	SA-08-021 Wolfurt KD08003E

SAFETY ALERT BULLETIN

Title: Tower Failure Due to Water Intrusion

Tower failure due to water intrusion

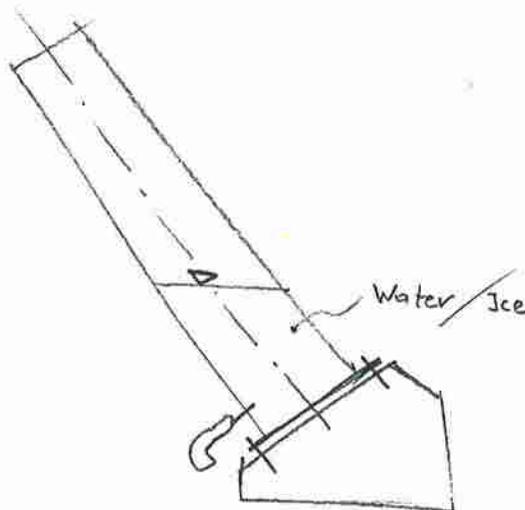
If with a resonance check, water/ice is found or suspected inside the tower within 4" (100 mm) of the top plate (see Section 3.1.2) **this shall be cause for immediate and continued closure of the lift to public transportation** and must be reported to the nearest Doppelmayr representation office for review and recommended repair procedures.

If with a resonance check, water/ice is suspected to be present within the tower but further than 4" (100 mm) from the top plate, a small hole 3/8" - 1/2" (10 - 12 mm) must be drilled near the tower base at the downhill side of the tower along the centerline of the lift 2" to 4" (50 - 100 mm) from the tower base to provide a pathway for water to escape. See illustration below.

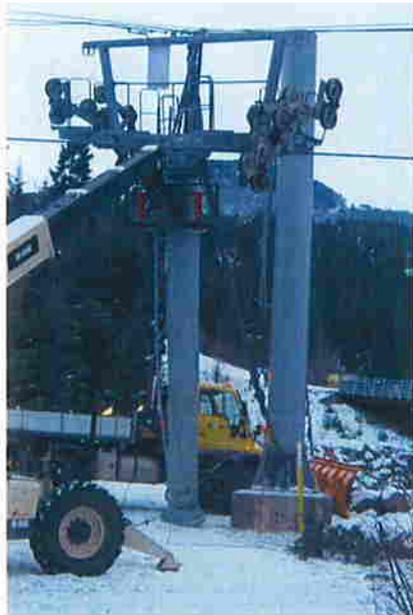
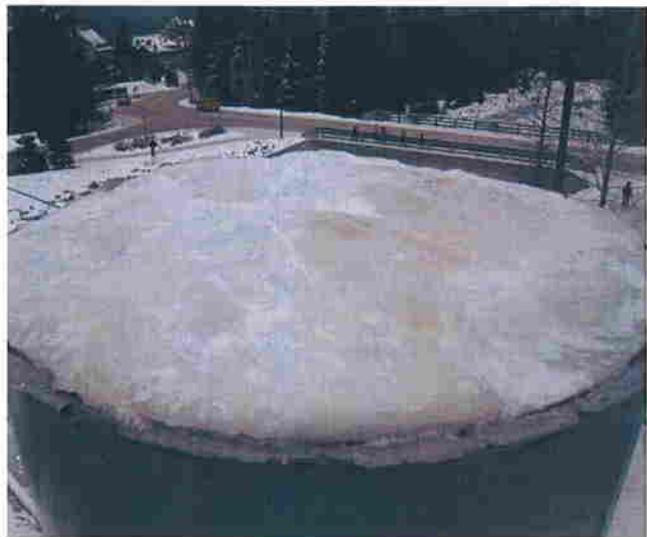
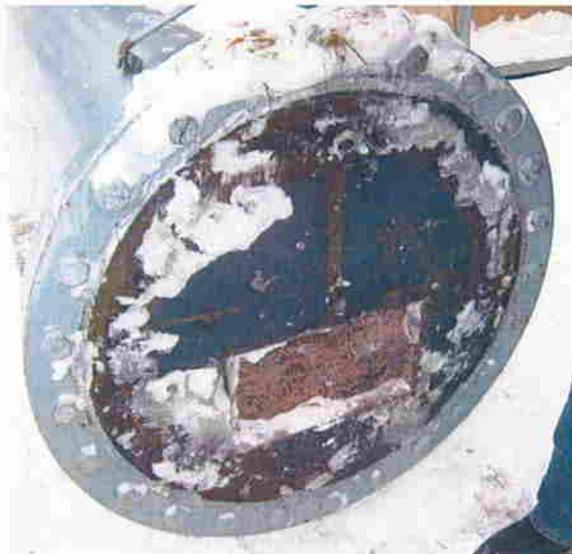
Tower with 2 x 6T/2FR assemblies;
16,7m tall; 9,7m of 30" tube spliced
to 7m of 24" tube.

Lower tower section filled approx.
5m with concrete, the remainder
with ice.

Bottom tower section top flange
plate was pushed off the shaft by
ice and caused top tower section to
separate and fall.

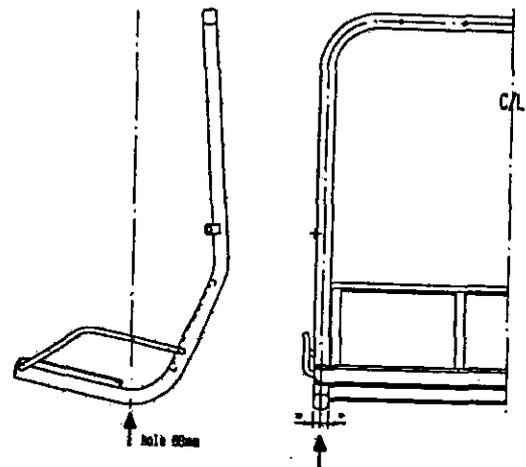
Recently, a case of severe corrosion has been found in a few chair bails of a triple chairlift in service since 1980. The corrosion went trough the bottom wall of the square tube of the chair bail at the lowest point of the chair (when installed on the cable). The corrosion appeared to the inspector as a small rust point and have been confirmed with a hammer (went trough).

We have observed that those chairs didn't have draining holes at the bottom of the chair bail, and that there was a lack of inside galvanized coating.

If you find a lack of draining holes, or blocked holes, at the bottom of a carrier with square tubes, please proceed to the next steps;

- Drill a 8 mm diameter draining hole at each side of the bottom of the chair bail as per figure beside.
- Once the hole is done, or unblocked, check the thickness of the remaining material, which should not reach the minimum value stated in table 1.

Thickness can be measured with a caliper or a depth gage trough the hole. In case of doubt, accurate thickness measurement is also possible by mean of an ultrasonic thickness gage.

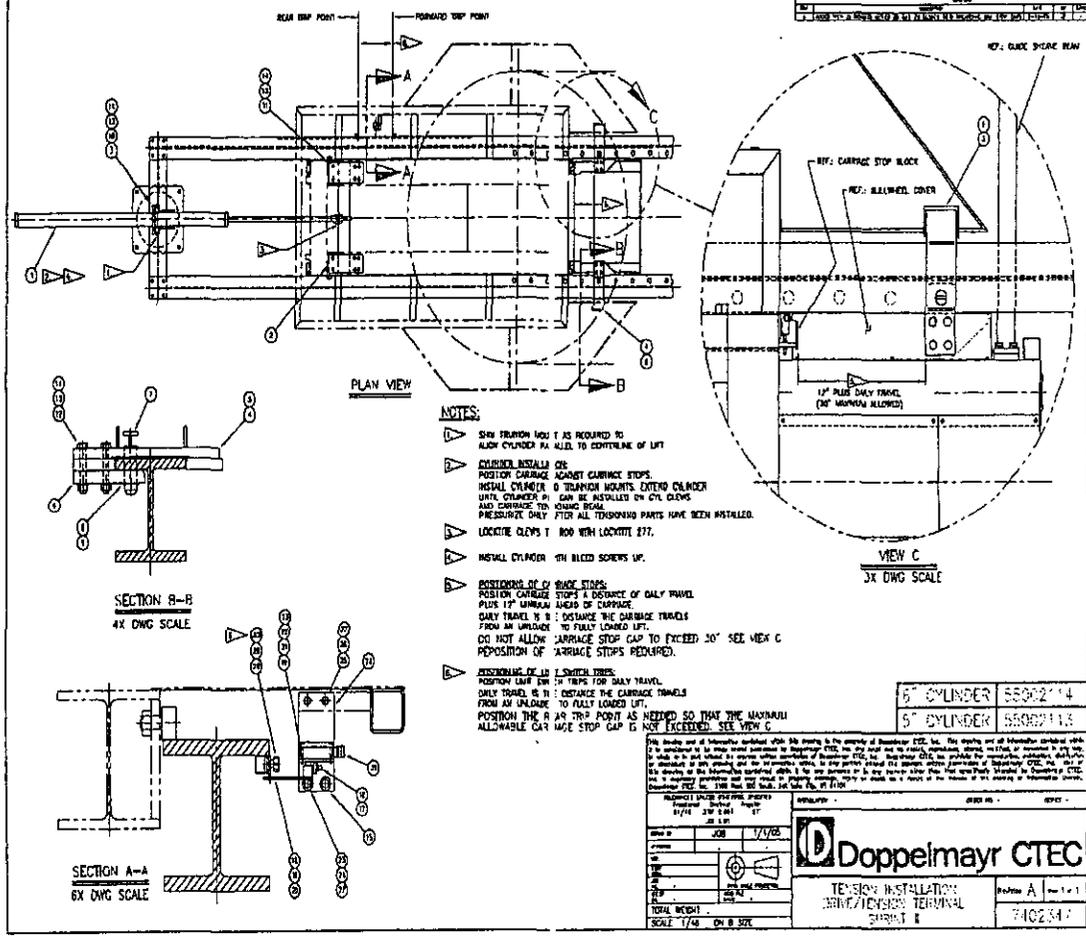
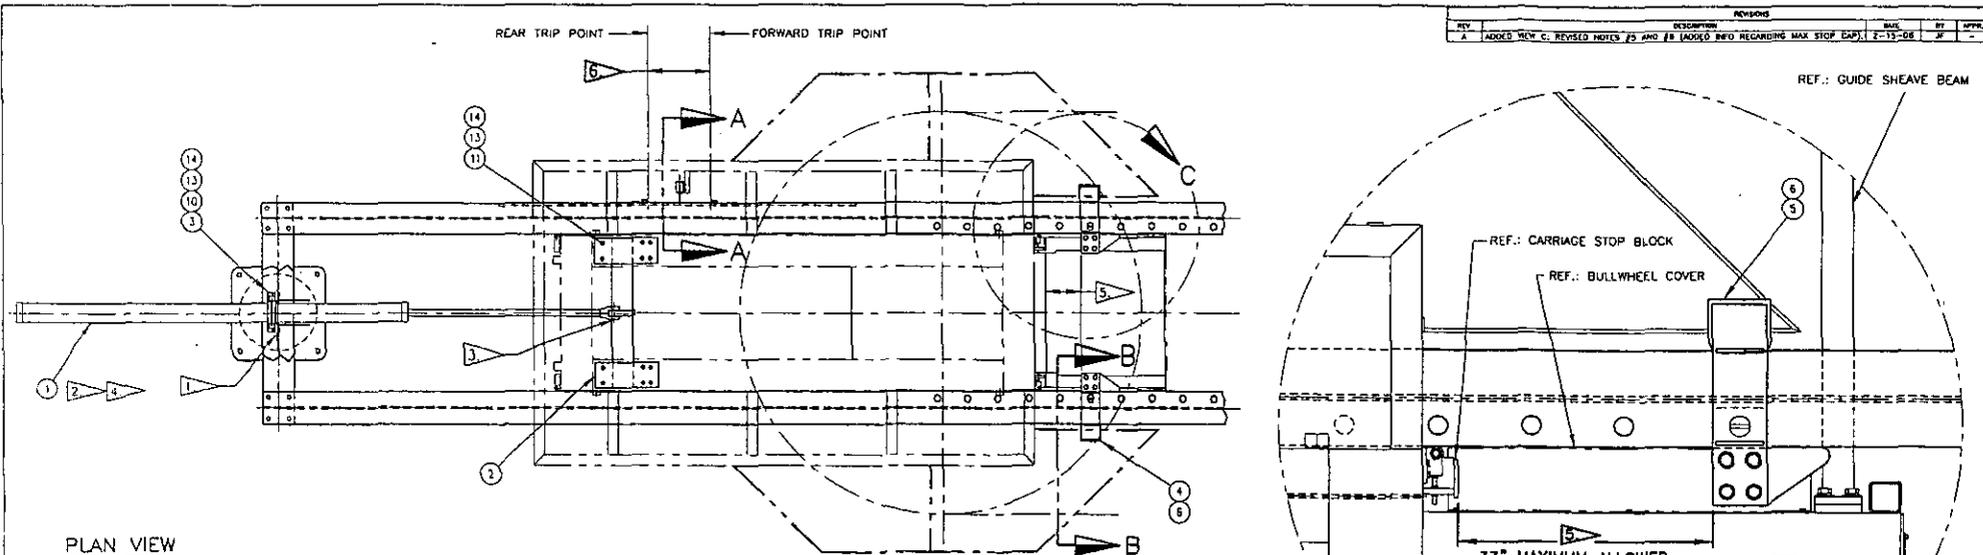
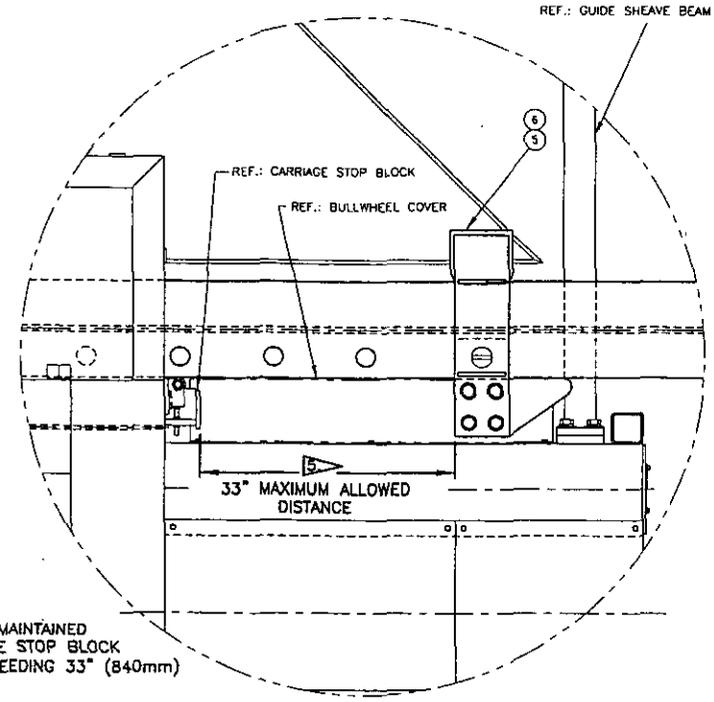
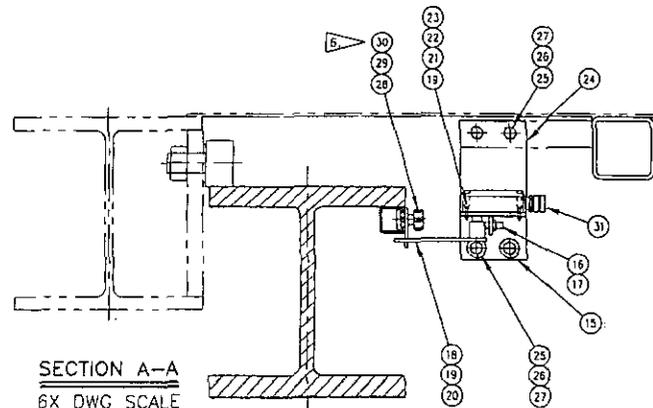
5 **POSITIONING OF CARRIAGE STOPS:**
POSITION CARRIAGE STOPS A DISTANCE OF DAILY TRAVEL PLUS 12" MINIMUM AHEAD OF CARRIAGE. DAILY TRAVEL IS THE DISTANCE THE CARRIAGE TRAVELS FROM AN UNLOADED TO FULLY LOADED LIFT. THE POSITION OF THE CARRIAGE STOPS MUST BE MAINTAINED TO PREVENT THE DISTANCE BETWEEN THE CARRIAGE STOP BLOCK AND CARRIAGE STOP (TYP BOTH SIDES) FROM EXCEEDING 33" (840mm) SEE VIEW C

6 **POSITIONING OF LIMIT SWITCH TRIPS:**
POSITION LIMIT SWITCH TRIPS FOR DAILY TRAVEL. DAILY TRAVEL IS THE DISTANCE THE CARRIAGE TRAVELS FROM AN UNLOADED TO FULLY LOADED LIFT. THE POSITION OF THE LIMIT SWITCH REAR TRIP POINT MUST BE MAINTAINED TO PREVENT THE DISTANCE BETWEEN THE CARRIAGE STOP BLOCK AND CARRIAGE STOP (TYP BOTH SIDES) FROM EXCEEDING 33" (840mm), INCLUDING ALLOWANCE FOR DAILY CARRIAGE TRAVEL. SEE VIEW C

See enlarged detail View C and Notes #5 & #6 on drawing 7402347 Rev. A attached

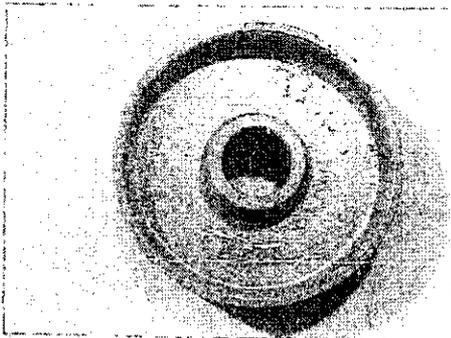
Picture 1.
320 drop sheave hub with marking P320 on one side

- This problem affects the **320 steel hubs used for drop sheaves**.
- **Only model 320 steel hubs (id. CCC12155) with the letter P320 on one side and no production date on the other side are affected (see picture 1 below).**
- 320 steel hubs **with production date** appearing on one side (see picture 2) **do not seem to be affected**.

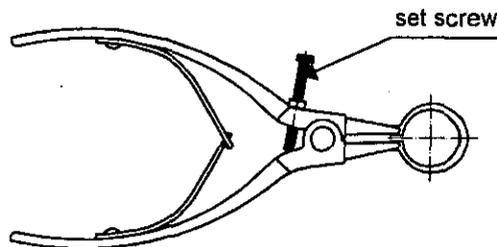
If the snap ring is not fitted correctly or missing, the bronze bushing may creep and as a result the grip may be blocked during the closing procedure!

This means that the grip leaves the station without being completely closed!

When fitting the snap ring, make sure that it will not be over-tensioned by excessive opening. Therefore it is advisable to use adjustable circlip pliers with a set screw.

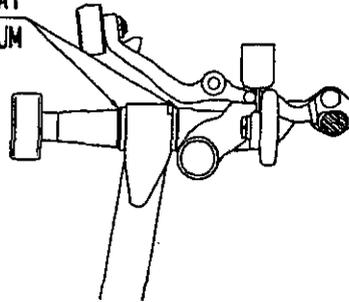
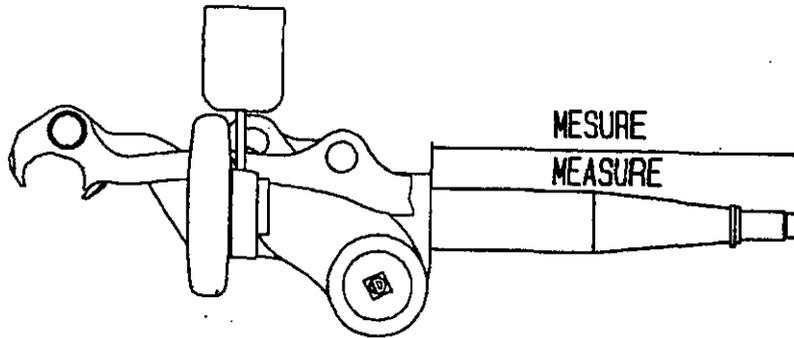
MOVEMENT OF HANGER AXLE ON DT GRIPS

On a few installations in North America (mainly in regions with high humidity and strong temperature fluctuations) there has been isolated cases where movement of the hanger axle in the fixed jaw has been detected due to condensation building in the bore of the fixed jaw.

The cavity behind the axle may collect water until the cavity is full. This could take several years. Once the cavity is full, with freezing conditions, micro movement may occur. Once movement has occurred, the enlarged cavity will fill with additional water and with freezing conditions, may cause further micro movements.

JEU LATERAL
LATERAL PLAY
3 mm MAXIMUM

Required value	Limit value
Length of hanger axle DT104	394.5 mm	397.5 mm
Length of hanger axle DT104G	489 mm	492 mm
Length of hanger axle DT106	395 mm	398 mm
Length of hanger axle DT108	395 mm	398 mm

Please report any movement to your Doppelmayr CTEC Service Representative. Do not attempt to pull hanger axle from fixed jaw by yourself as a specific procedure with specialized tooling with high forces (6 to 8 tons) is required or irreparable damage may occur.

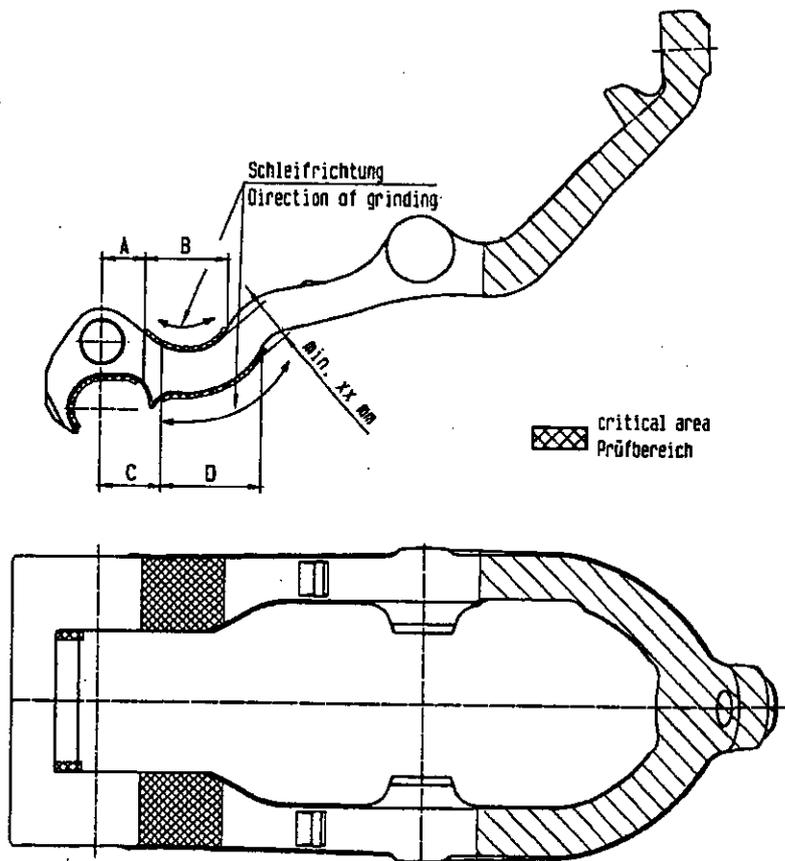
Graph 1: Critical areas and critical dimensions, movable jaw

* Grip jaw width: 162 mm

° Grip jaw width: 250 mm

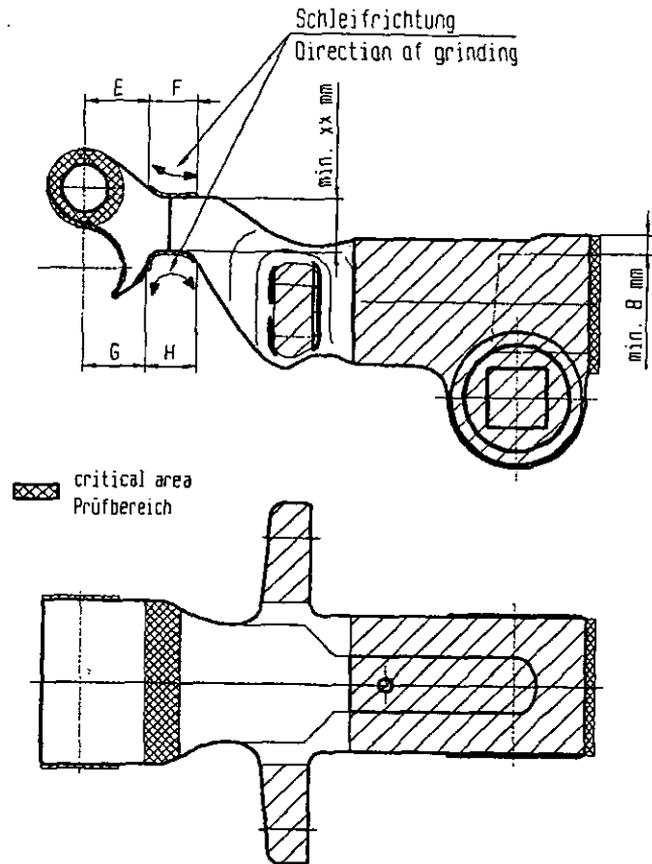
Graph 2: Critical areas and critical dimensions, fixed jaw

DT 104	DT 106	DT 108
E	28 mm	26 mm	50 mm
F	35 mm	50 mm	45 mm
G	34 mm	40 mm	45 mm
H	30 mm	37 mm	36 mm
XX	29 mm	33 mm	38 mm

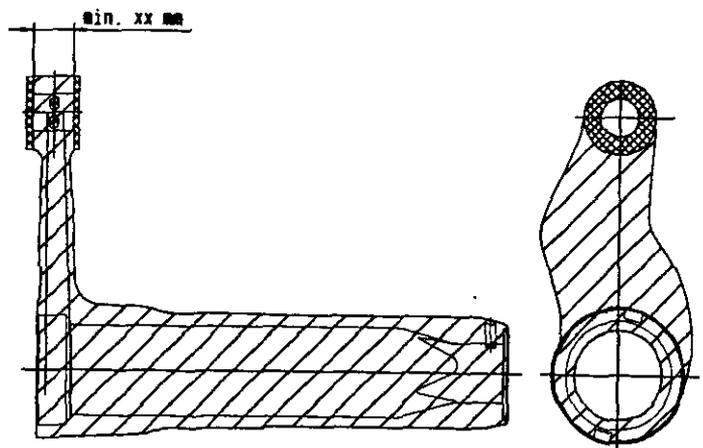
Graph 3: Critical areas and critical dimensions, torsion tube

DT 104	DT 106	DT 108
XX	25 mm	29,5 mm	29.5 mm

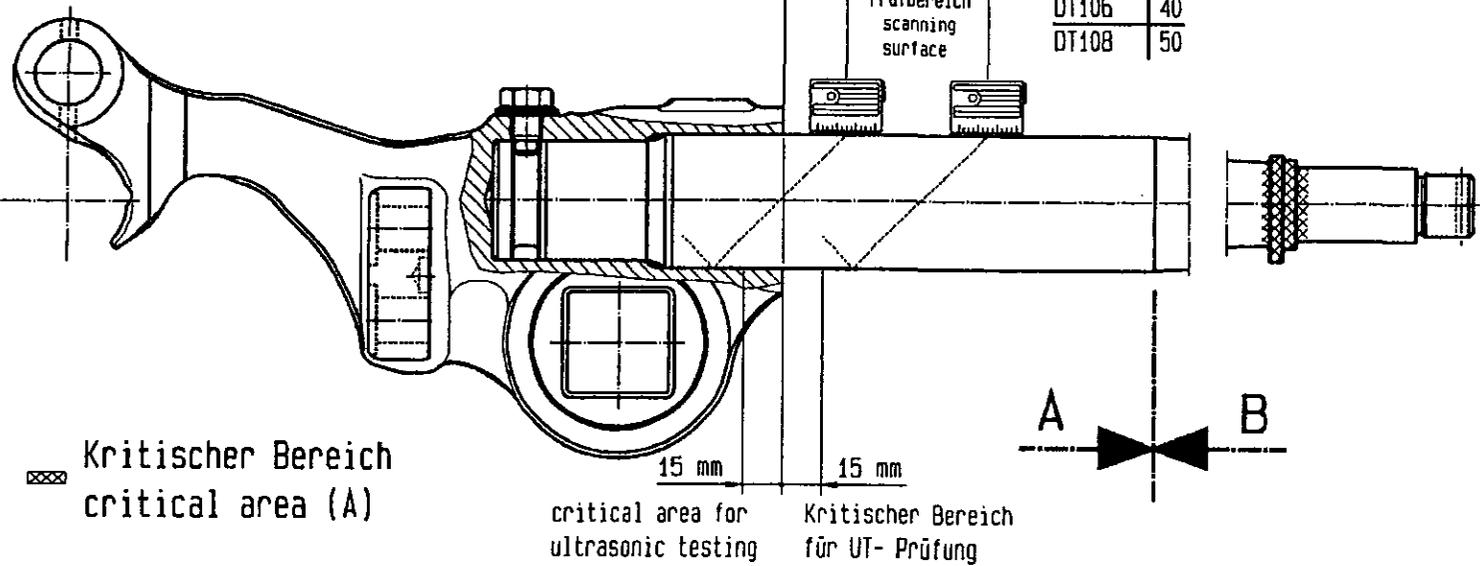
Ultrasonic inspection shall only be carried out in the critical area (see **graph 4**) of the hanger axle. The hanger axle shall be tested in an assembled condition.

100% - Prüfung am gesamten Umfang
 100% complete scan of cylindrical face

Kritischer Bereich
 critical area (A)

critical area for
 ultrasonic testing

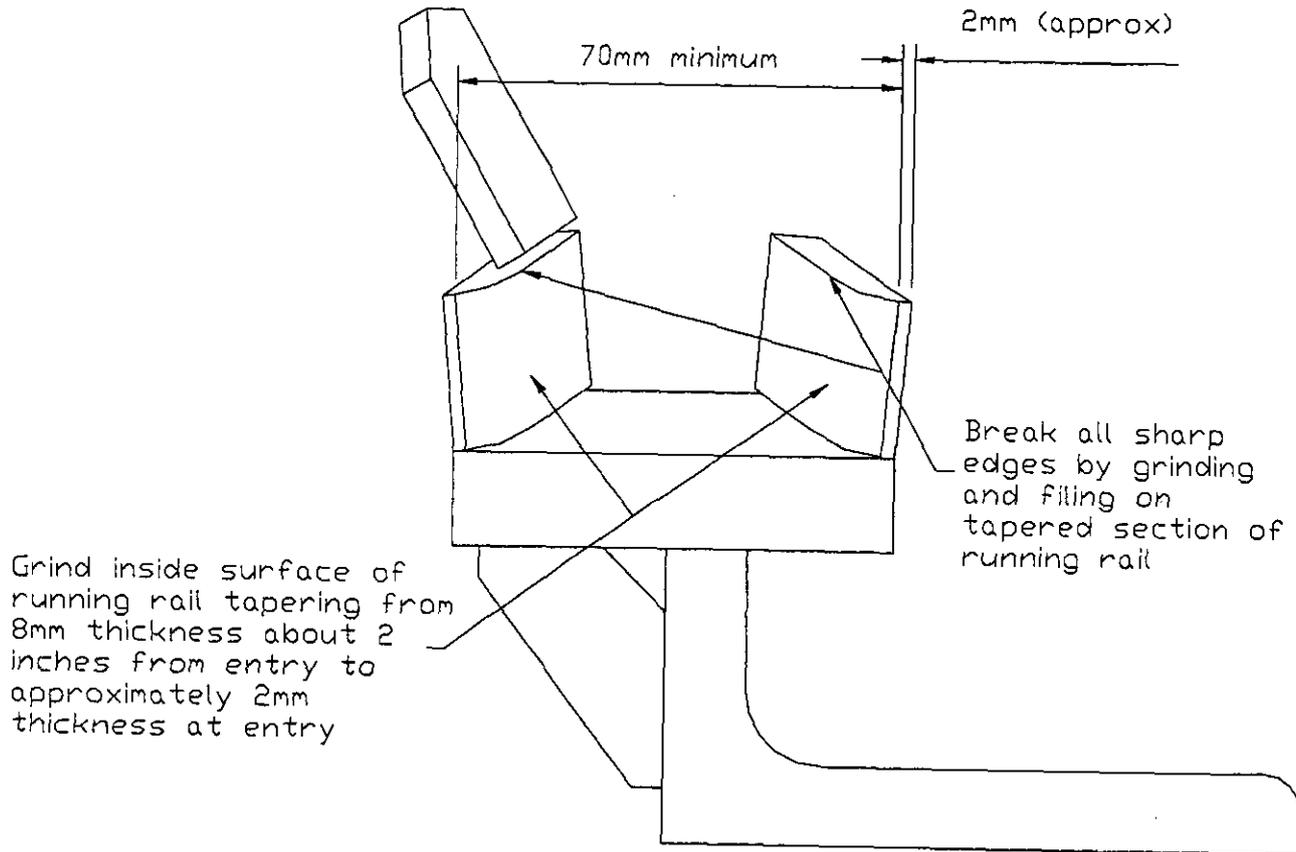
The upward travel of the trumpet must be limited to prevent excessive swing of the carrier/grip as the running wheel is entering the running rail. Currently, the upward travel is limited by the shock absorber. An upward travel stop must be added similar to the lower travel stop.

2) Add Travel Stop to Limit the Upward Travel of the Trumpet.

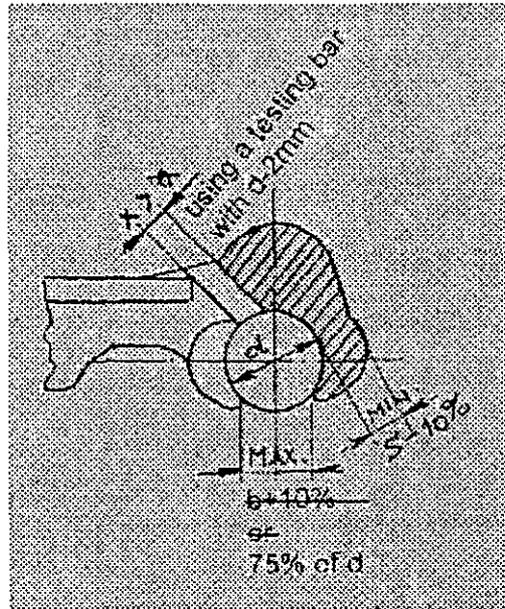
This sketch concerning the distance between the 2 grip jaw tips had two criteria included:

- 1.3 Distance between the tips of the two grip jaws:
The distance "b" between the two grip jaws should be max. 75% of the rope diameter.

- ◇ Please delete:
"b + 10% or".
- ◇ The following line remains unchanged:
"b max. = 75% of d".

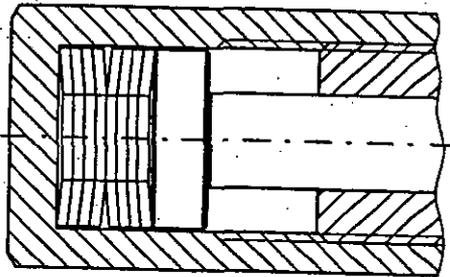
In view of the short movement of the spring mechanism in the case of spring pack SW50 it is particularly important to ensure that the cup springs are correctly packed.

Correct packing with 8 cup springs:

Packed in 2 sets of 4

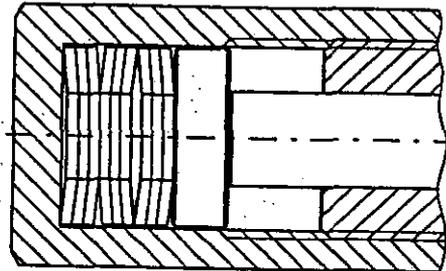
Correct packing with 9 cup springs:

Packed in 3 sets of 3

Spring packs SW50 with 8 cup springs can be converted to 9 cup springs.

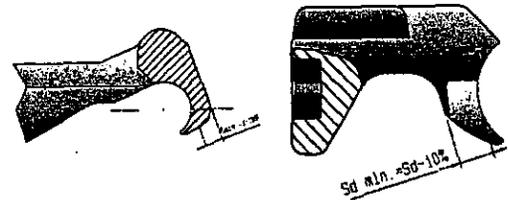
1.1 Thickness of grip jaw:

A 10% reduction in the thickness of the grip jaw compared to the required value stated on the drawing is acceptable.

$$S_{min} = S - 10\%$$

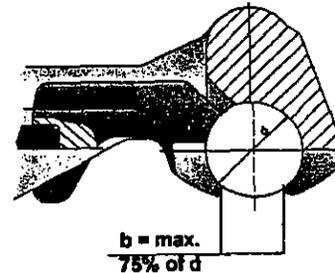
1.3 Distance between the tips of the two grip jaws:

The distance " b " between the two grip jaws shall be max. 75% of the rope diameter.

$$b = \max. 75\% \text{ of } d$$

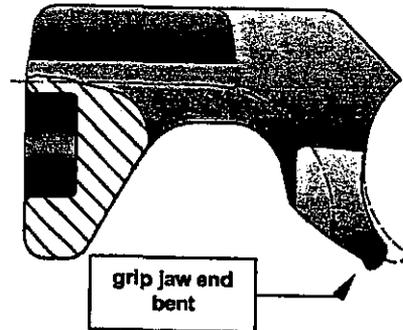
1.5 Bent thrust jaw:

Particularly in the case of surface lifts if a (high) torque is continually applied when tightening the grip (where there is contact between rope strands).

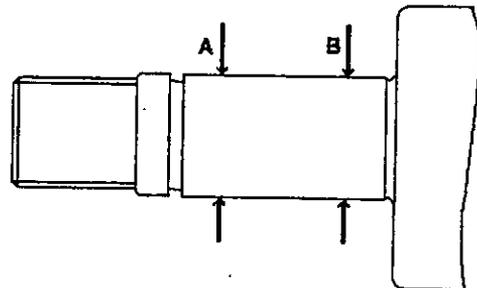
1.6 Play between grip shaft and hanger head bushing:

The clearance between the grip shaft and the bushing can be partly compensated by fitting new bushings. If the grip shaft is worn beyond the following criteria, the grip shall be replaced.

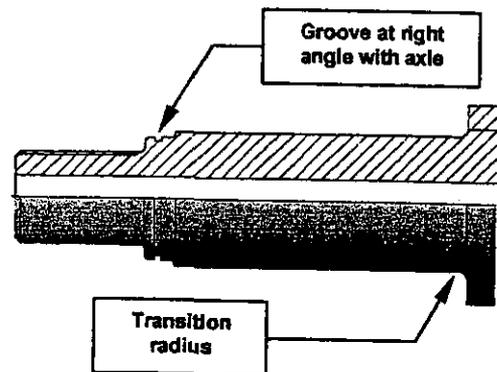
1.7 Shape of snap ring groove:

The outer contact surface for the snap ring in particular must be even and at right angles to the axis of the grip shaft. There shall be no evidence of snap ring coming out of the groove.

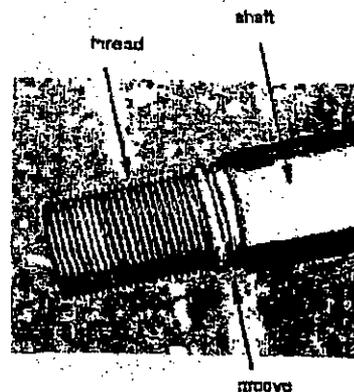
2.5 Damaged thread in/on grip shaft:

The thread is responsible for generating the grip force exerted on the rope. If the thread is damaged, stiff or has too much play, repair or replacement is necessary.

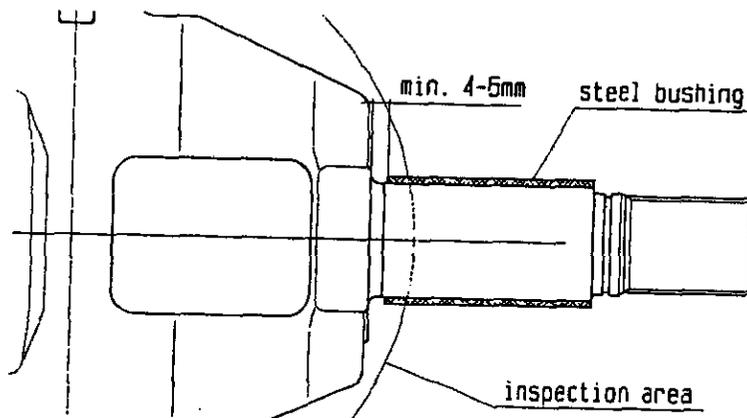
If a sleeve was added to increase the shaft diameter, the gap between the sleeve (steel bushing) and the grip shoulder (see graph) must be at least 4 to 5 mm.
Otherwise, it is not possible to perform a valid MT-inspection in this area!

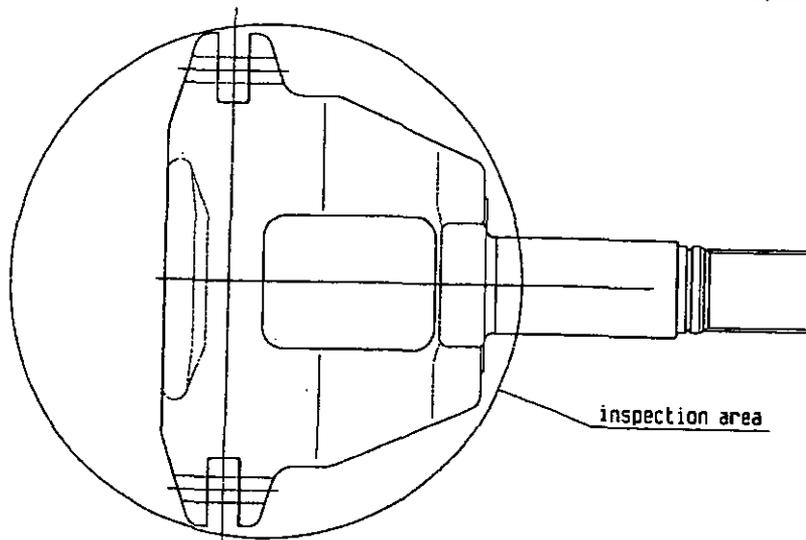
- Magnetic particle inspection is **mandatory** in **critical areas**.
For critical areas see graph below.
- Magnetic particle inspection is **mandatory** on **unacceptable visual indications**, as per D3.1.2.

- Maximum depth of grinding: 5% of thickness, max. 3 mm
- Diameter of grinding exceeds 25 times depth
- Grinding must be smooth (surface finish minimum N6 to ISO 1302) and free of nicks.
- Local hardening and hardening cracks due to grinding must be avoided!

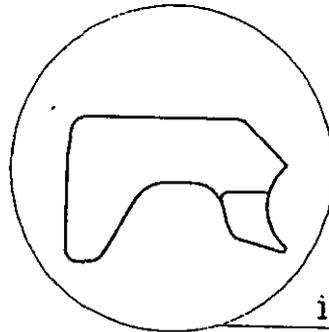
inspection area

Magnetic particle inspection is **mandatory** on the **whole surface** of the moveable jaw.

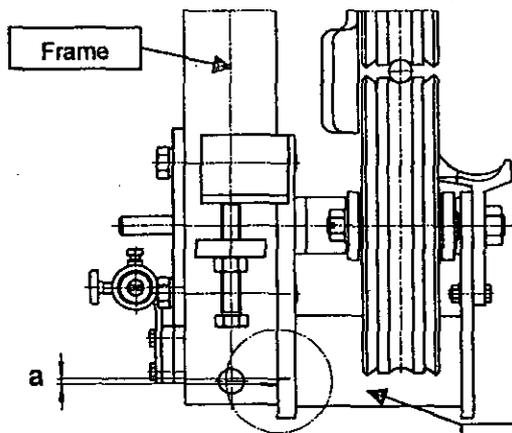
Adjustment of 2T/2N, 4T/2N, 4N/2T, 8T/4N and 8N/4T sheave assemblies of type A, C and OE

In addition, please also check the setting of the adjustable 2-wheeler evener frames of the combined sheave assemblies and readjust them if need be. For correct adjustment refer to the sketch.

Adjust the sheave assembly by relocating the support bracket of the 2-wheeler evener frame:

1. Relocate the adjustable 2-wheeler evener frame until all sheaves contact the rope.
2. Mark the position on the frame and on the support bracket of the 2-wheeler evener frame with a coloured pen.
3. Adjust the 2-wheeler evener frame at dimension "a" to increase the sheave pressure.

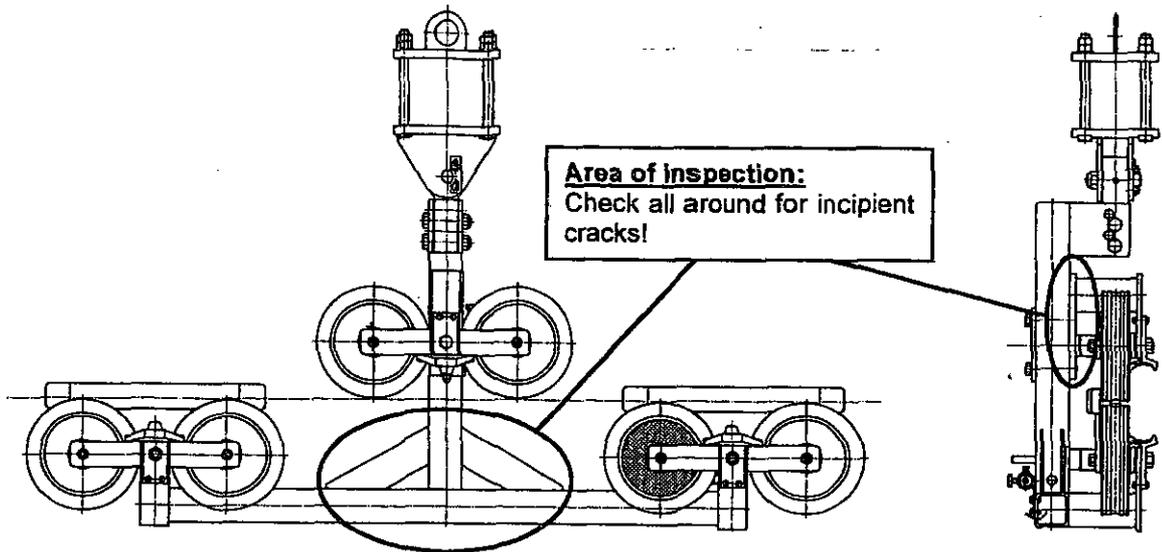
4T/2N resp. 8T/4N sheave assembly

If you find any incipient cracks during the check or obvious vibrations during operation, please inform Doppelmayr immediately so that we can decide the further measures to be taken.

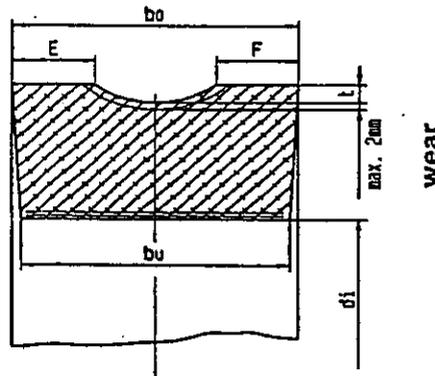
Max. permissible wear in the groove
2 mm

Max. permissible eccentricity of
groove 2 mm

The permissible wear of 2 mm indicated in the latest operation manuals assures that in the most unfavorable case (crosswinds, unevenly loaded carriers, etc.) the required swing clearances are being met and no contact of the grip main body on the sheave side plate exists.

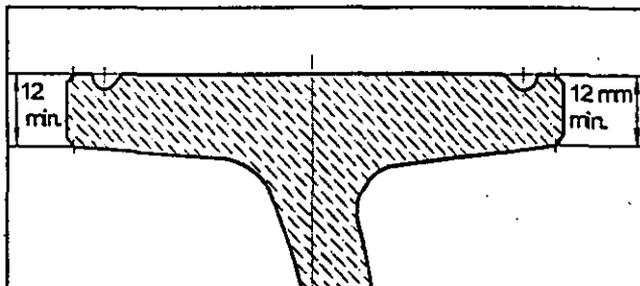
Picture 1

"Variant C" side plates shall be installed only on 400 / 401 aluminium hubs with a rim thickness of 12 mm and over (see picture 1, appendix 2) or, when applicable, on drop sheaves identified in table 2, appendix 2.

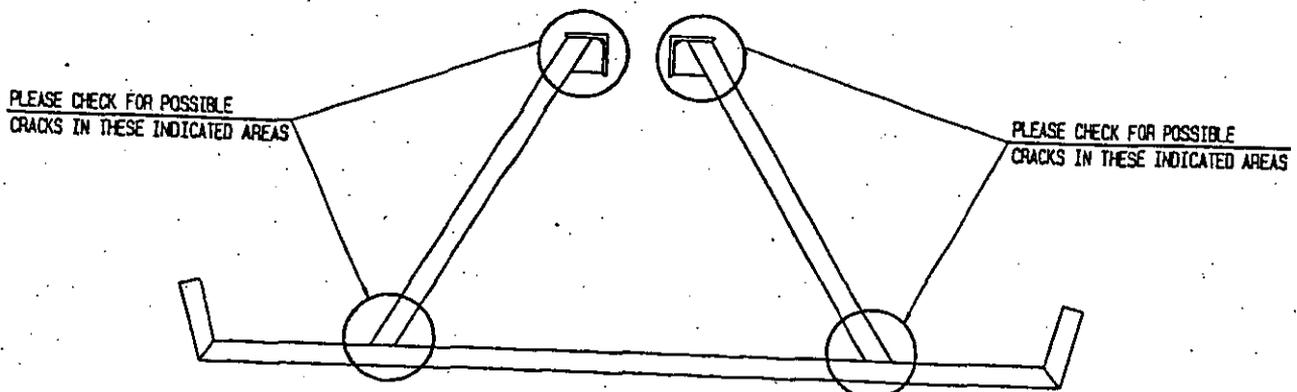
CATWALK 4T/4D

During the last season, one of our customers found indication of cracks on a 4T/4D catwalk during his periodic visual inspection. The catwalk failed by natural vibration at the end of the season. According to our records, you have these types of catwalks on your Doppelmayr 4T/4D sheave assemblies. Therefore, we kindly ask you to inspect your catwalks in the areas as described in drawing below. In case of doubt, perform a non-destructive test by magnetic particles. If any indication of cracks is found, remove the catwalk and report immediately to your Doppelmayr CTEC representative. We thank you in advance for your collaboration on this matter.

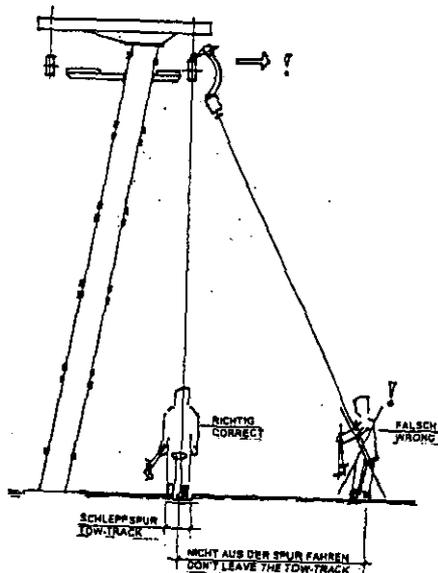
- 1) When a lift user leaves the tow track to the side away from the tower shaft, there is a risk that the resulting transverse pull leads to rope derailment from the sheave assembly. This can result in complete rope derailment.

- Post the Terms and Conditions of Transport and/or the 6 point information sign including the information "Stay in track when riding the lift".
- Put up the information sign "Stay in track" (Zigzagging prohibited).
- Do not groom the track too broad and provide for a tow track.
- An additional measure may be to remove the ladder eyes on the downhill side of the tower shafts.

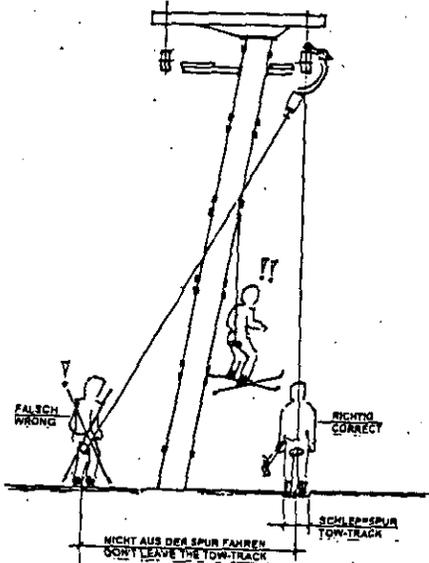
- 2) When a lift user leaves the tow track to the side towards the tower shaft or beyond, there is a risk of rope derailment as well.
 If the towing cable becomes entangled on one of the ladder eyes on the downhill side of the tower, the lift user may be lifted up and as a result fall down from a height of several metres.

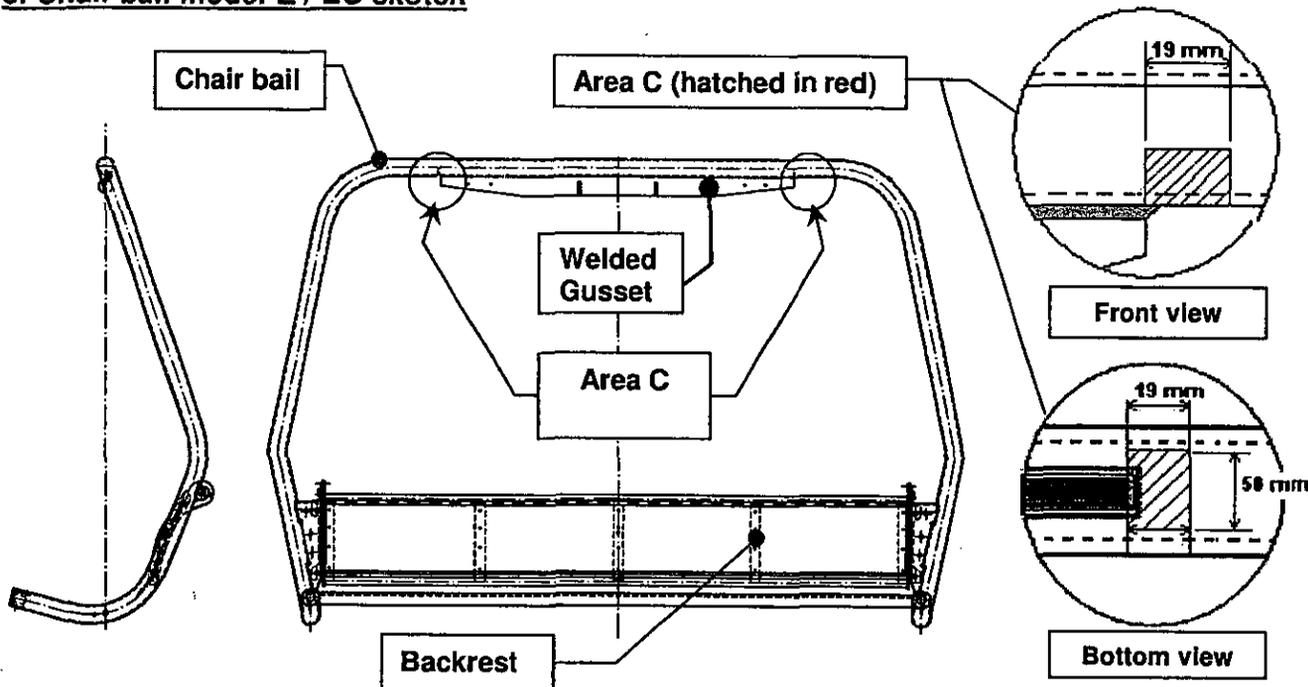
5. Chair bail model E / EC sketch

The cracks initiate at the location of the weld. If a small indication is found in the weld, and if appropriate repairs are made, it may be possible to prevent the indication from ever propagating into the base metal of the chair bail tube thereby extending the life of the bail. Detailed examination of welds on several lifts in service using magnetic particle inspection reveal that minor indications within the weld itself may exist, yet very few have propagated into the base metal of the bail tube. Therefore, we feel it is a costly and unnecessary action to repair all weld irregularities if only a small percentage will eventually propagate into the base metal of the bail tube.

Following the bulletins **SA-06-005** and **SB-06-015** concerning the transverse cracks found in **Area C** of chair bails tubes of Doppelmayr quad chairs model E/EC (see **sketch page 3**), please find our final statement.

Any crack, regardless of the length, which has propagated into the base metal of the chair bail tube **and away from the weld**, is a cause for rejection. The chair bail shall be removed from service – no repair allowed. If the indication is confined in the weld seam and has not propagated into the base metal of the tube, the chair may stay in service

Every Year : All bails shall have a **thorough visual inspection in area C** by an experienced technician. If a defect is suspected, perform a magnetic particle examination to determine whether the bail is acceptable or not as per **section 4**.

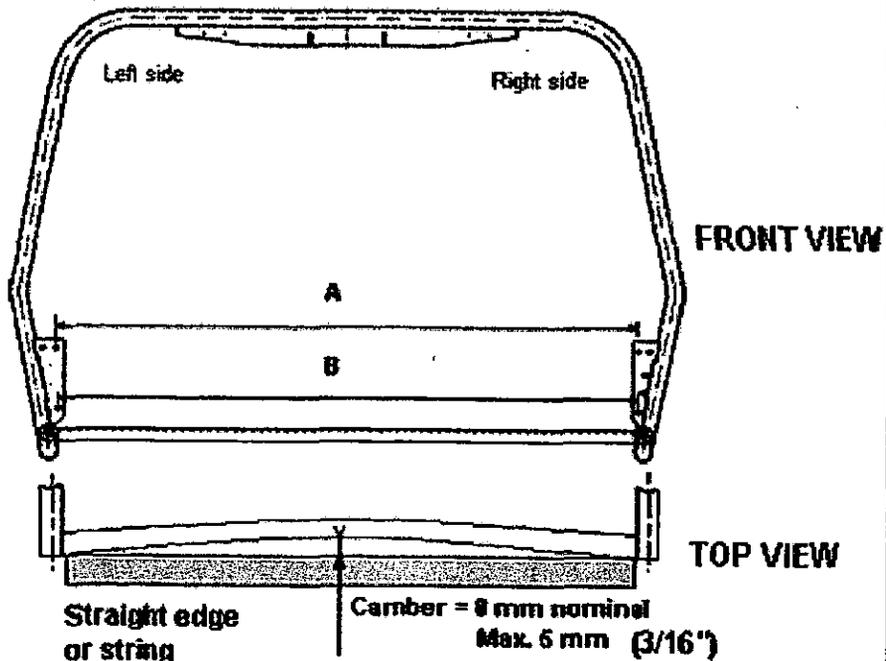
To determine if the chair bail is deformed :

- Measure the camber of the angle bar in the front. If the camber is less than or equal to 5 mm (3/16") the chair bail is considered to be "conforming"
- If the camber exceeds 5 mm (3/16") remove the seat back and measure the dimensions A and B.
- If dimensions A or B are less than 2002 mm, the bail is considered as "deformed"
- If dimensions A or B are equal or greater than 2002 mm, the bail is considered as "conforming".
