SUPPLEMENT TO THE BIG ELI® WHEEL MANUAL

Since this Manual was last revised there have been several bulletins sent out to owners/operators of record. This supplement will cover that material which was sent out, as well as new information, but which was not covered by this Manual.

Bulletin

For All Big Eli® No 16 Wheels
Before Serial No. 1080-59

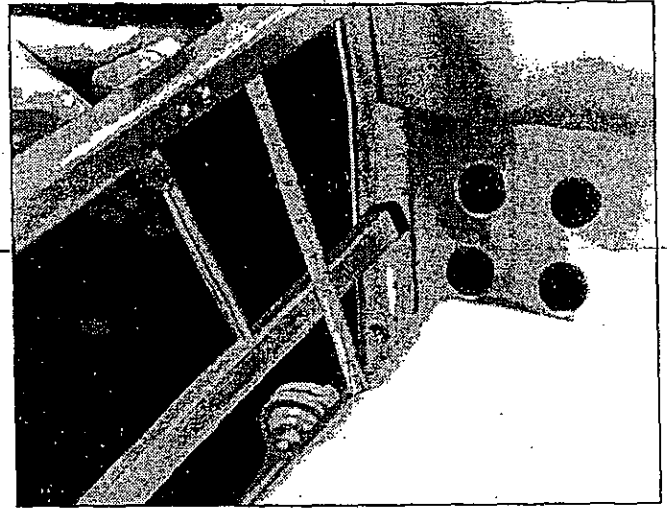
FIGURE 13

The lap bar is a mandatory modification which should be on all Big Eli® Wheel seats. The purpose is to provide added protection for young children who may be riding with adults or by themselves. From the bottom of the lap bar to the top front edge of the cushion the distance should be no greater than 3". The measurement should be made on the end of the lap bar closest to the handlebar hinge, as shown in Figure 13.

IF THE FRONT EDGE OF THE SEAT CUSHION COLLAPSES SOMEWHAT THROUGH HEAVY USE SO THAT THE DISTANCE BETWEEN THE BOTTOM OF THE LAP BAR AND THE SEAT CUSHION INCREASES TO MORE THAN 3", THEN THE SEAT CUSHION SHOULD BE REPLACED.

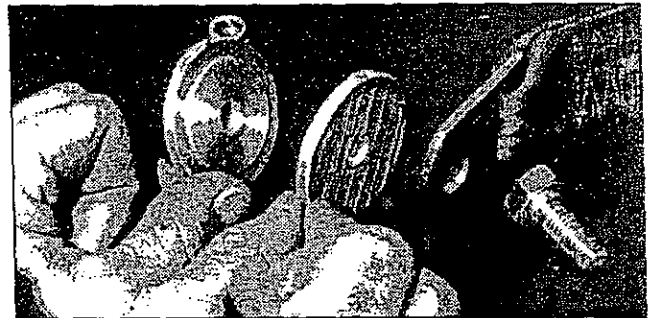
FIGURE 14 - PARTS OF THE SEAT BELT ASSEMBLY

There are some States which are now requiring the use of seat belts in all Ferris Wheel seats. We have available seat belt kits which can be added to any Big Eli® Wheel steel or aluminum seats. The assembly can be added to the seat using only wrenches; no drilling or cutting is necessary (see Figures 14 & 15).

The seat belts conform to Motor Vehicle Safety Standard 290-302. In our testing the installed seat belt withstood a load in excess of 1500 pounds without breakage or release of the belt.

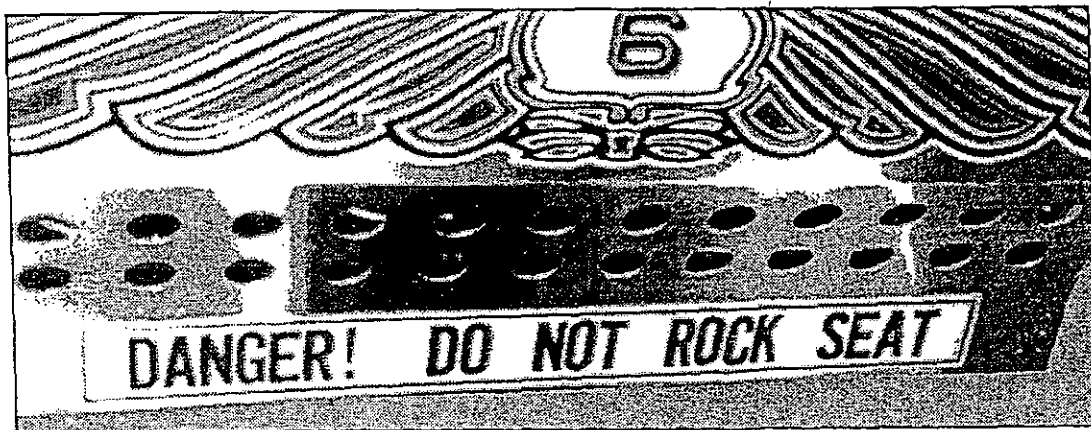
FIGURE 17

It has always been the position of Eli Bridge Company that passengers should not rock the seats on Big Eli® Wheels. This has been stated in every manual for more than twenty years. If a passenger refuses to stop rocking the seat, then he should be removed from the ride before he injures himself or others.

We have available decals, shown in Figure 17, which can be applied to the back of each seat at the very bottom, warning against rocking the seat. They can be used on all Big Eli® Wheel seats. THE INSTALLATION OF THESE WARNING DECALS IS MANDATORY ON ALL BIG ELI® WHEEL SEATS.

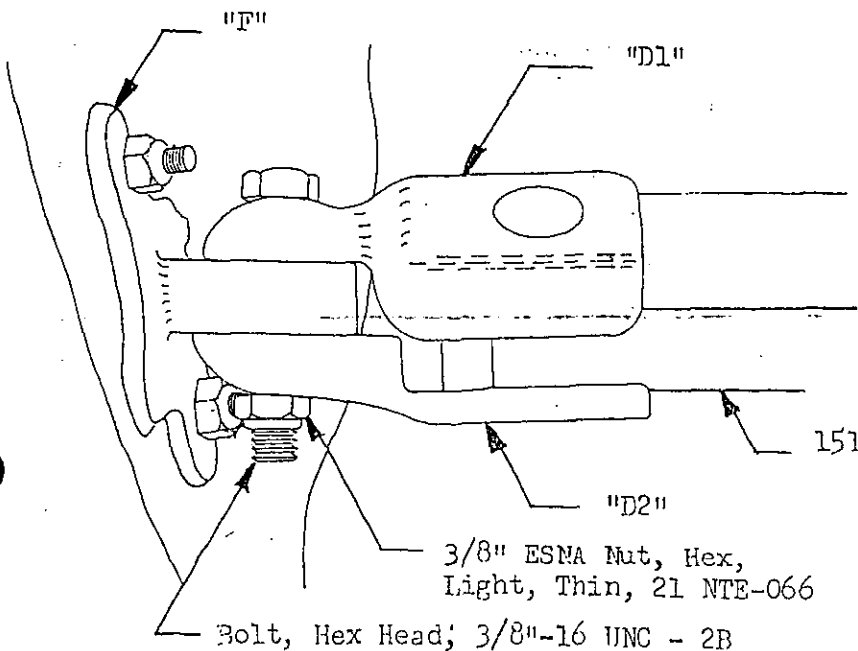
SUBJECT: Wheel Seat Handlebar Hinge

"D1" and "D2" castings are bent toward each other. This then squeezes the two castings against the "F" hinge, so that the handlebar will not swing freely.

We are installing on all new seats a 2 inch long 3/8" coarse thread bolt, and outside the "D2" casting we are adding a 3/8 inch coarse thread thin height self-locking nut with a Nylon insert. The bolt should be tightened enough to hold the two castings to the handlebar, but not so tight that they are bent. Then the self-locking nut should be

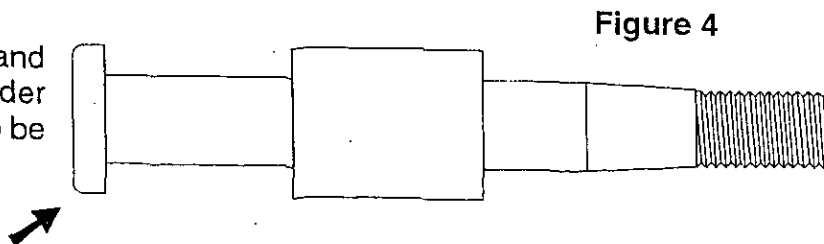
Figure 4

To eliminate even this possibility, in recent years we have been adding a 1/8" radius to the end of the seat pin, as shown in Figure 4. This rounded edge eliminates any possibility of the seat pin resting on the bottom edge of the sheet metal of the hair guard bracket.

Rounding this edge also performs another function. As the "Y" casting and the seat pin may become worn, there is sometimes a tendency for the end of the seat pin to rub against the side of the seat, occasionally wearing a hole in the seat. This is not a safety problem, but rounding the edge provides a small additional clearance and keeps the sharp corner from bearing against the side of the seat.

Rounding off this edge can be done easily and quickly in any machine shop, and we consider adding the radius to the end of the seat pin to be a mandatory change.
