TMS SCRAMBLER BULLETIN NUMBER 1

SUBJECT: BREAKAGE OF LANDING GEAR CYLINDERS STACK VALVE

TMS SCRAMBLER BULLETIN NUMBER 4

SUBJECT: UNIT POLE AND SPLIT RING WEAR

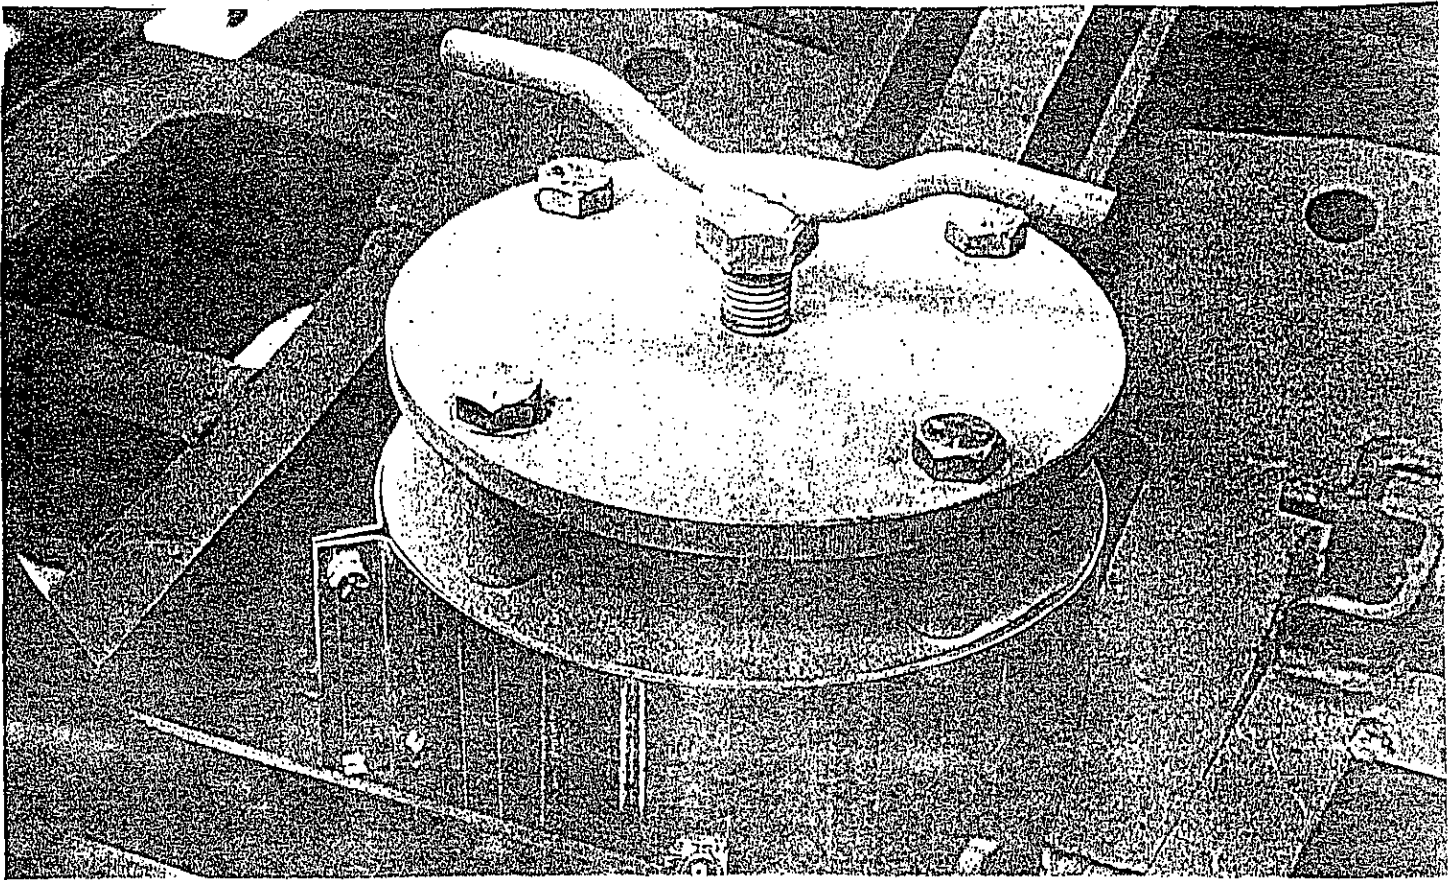
PICTURE NO. 1

Picture No. 1 shows the complete installation, and Picture No. 2 shows a cross-sectional drawing of the assembly. This modification has been reviewed and approved by Chief Engineer Albert M. LaRou of the Sealmaster Bearing Company, and J. E. Mickelson, Product Engineer of Morse Industrial Corporation. Mr. LaRou felt that the extra loading of the Sealmaster SF-47 bearing as a result of highway travel warranted a change to the Morse RFP-215-C tapered roller bearing flange unit. Mr. Mickelson confirmed this, and stated that with this higher capacity tapered roller bearing on the TMS Scrambler top sweeps we could go back to the 3000 hour/4 year (whichever comes first) bearing replacement schedule which we have used for many years on ground-model Scramblers.

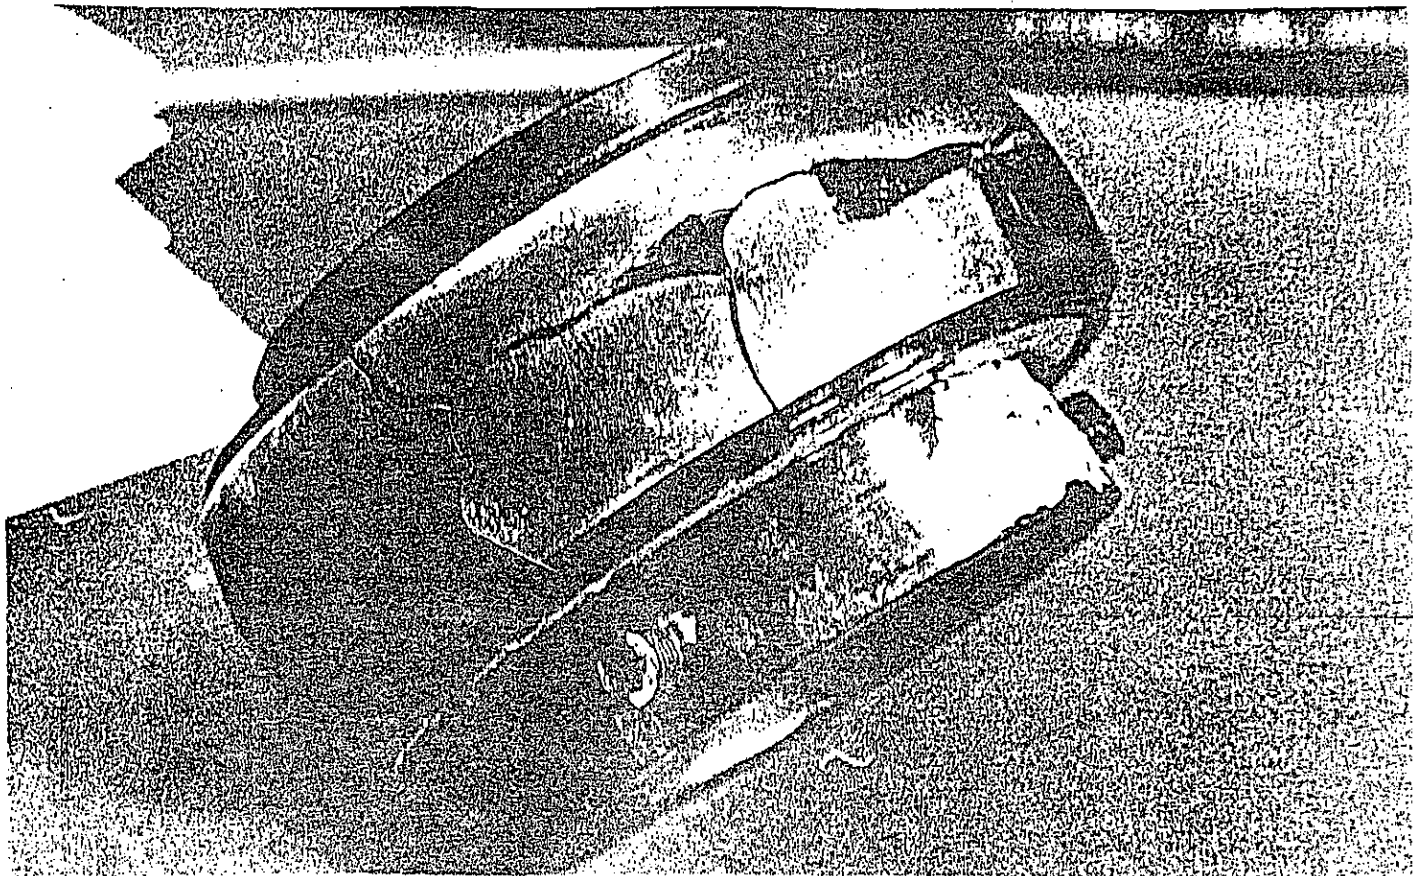
PICTURE NO. 3

The top of the split ring was worn as shown in Picture No. 3. Originally the top of the split ring was flat.

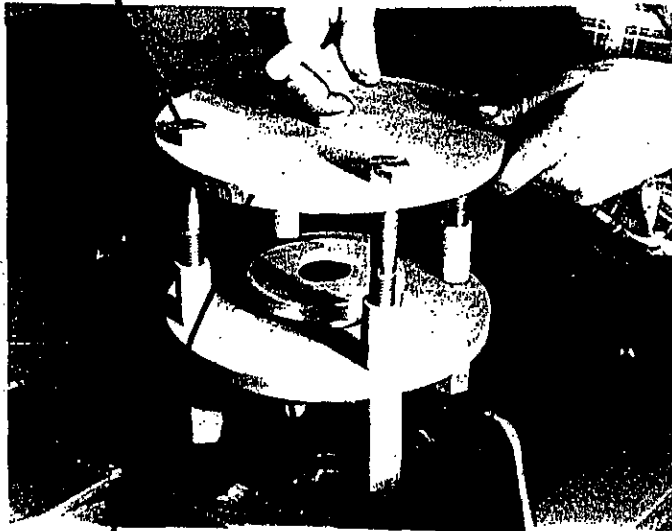
PICTURE NUMBER 2

To start, first remove the rain shield, not shown in the cross-sectional drawing. Then remove the four 5/8" hex head capscrews shown in Picture No. 2 along with the screw down weldment No. 10. This will expose the safety lip plate (See Picture No. 3). Remove the Allen head capscrew and safety lip plate along with the secondary drop prevention plate No. 7 (See Picture No. 4)
