ALL STEEL PORTABLE
Big Eli
FERRIS WHEELS

Scramblers
E.L.I. POWER UNITS

SAFETY BULLETIN

URGENT WARNING

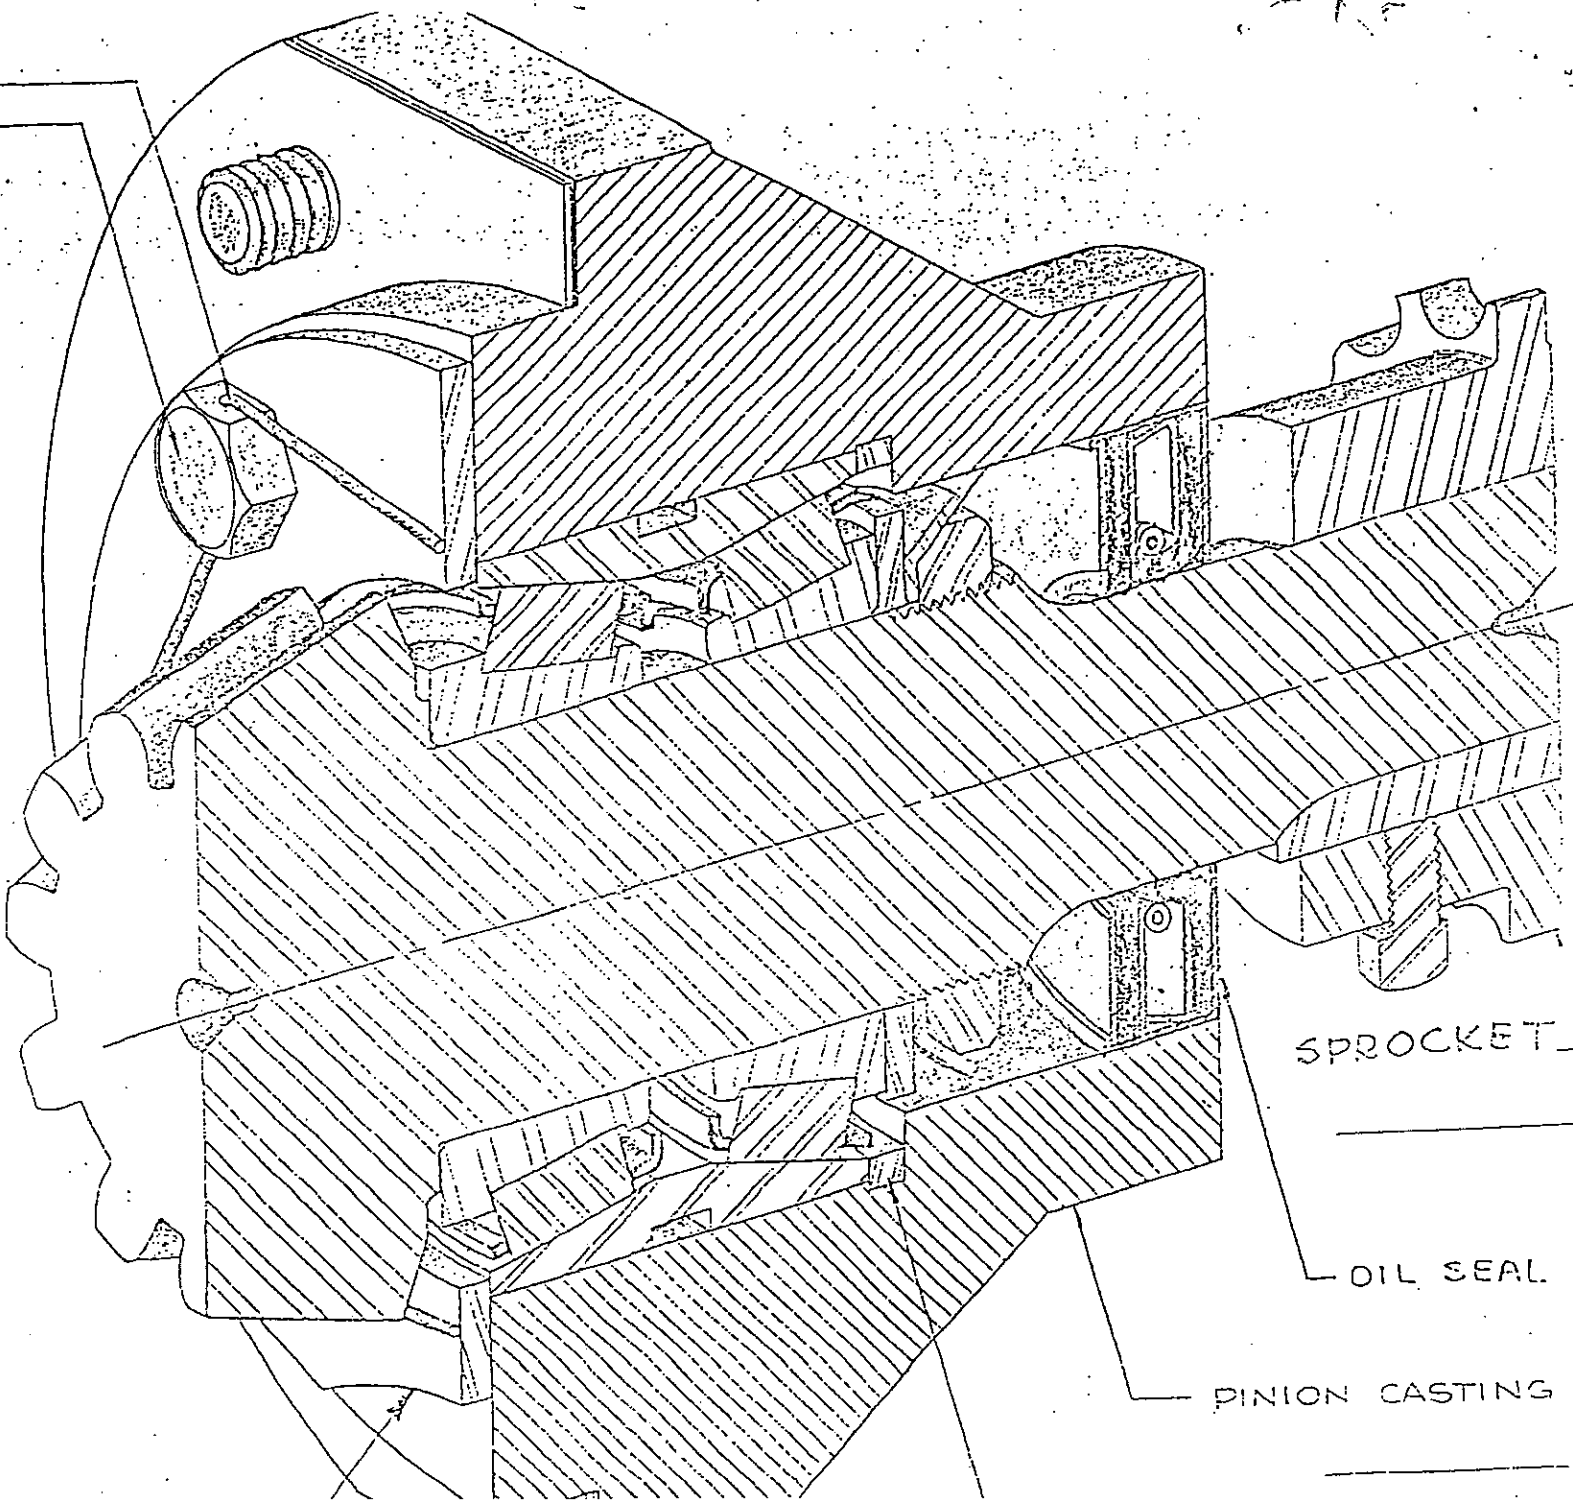
The original seal used in the pinion casting assembly was a Chicago Rawhide "Perfect" oil seal Part No. 15245. The manufacturer discontinued that seal, and we could not find an interchangeable replacement from any other manufacturer. The closest seal in size was a Chicago Rawhide Part No. 15250. The original seal had an outside diameter of 3.066", and the replacement had an outside diameter of 3.130".

Therefore, to replace the seal it is necessary that the pinion casting assembly be disassembled and the casting re-bored to $3.125" \pm .0015"$.

1. Remove the pinion casting assembly from the Scrambler, by taking out the six cap screws that secure it to the stationary base gear pot cover plate.
2. Remove the chain sprocket from the end of the shaft.

3. Remove the locking wire. It is 19 gage, dead soft iron wire, two feet long. When the time comes to replace it, thread the wire through the bolt heads so that loosening of the bolt will cause the wire to tighten, and then twist the ends of the wire together tightly with four turns to keep it from unwinding.

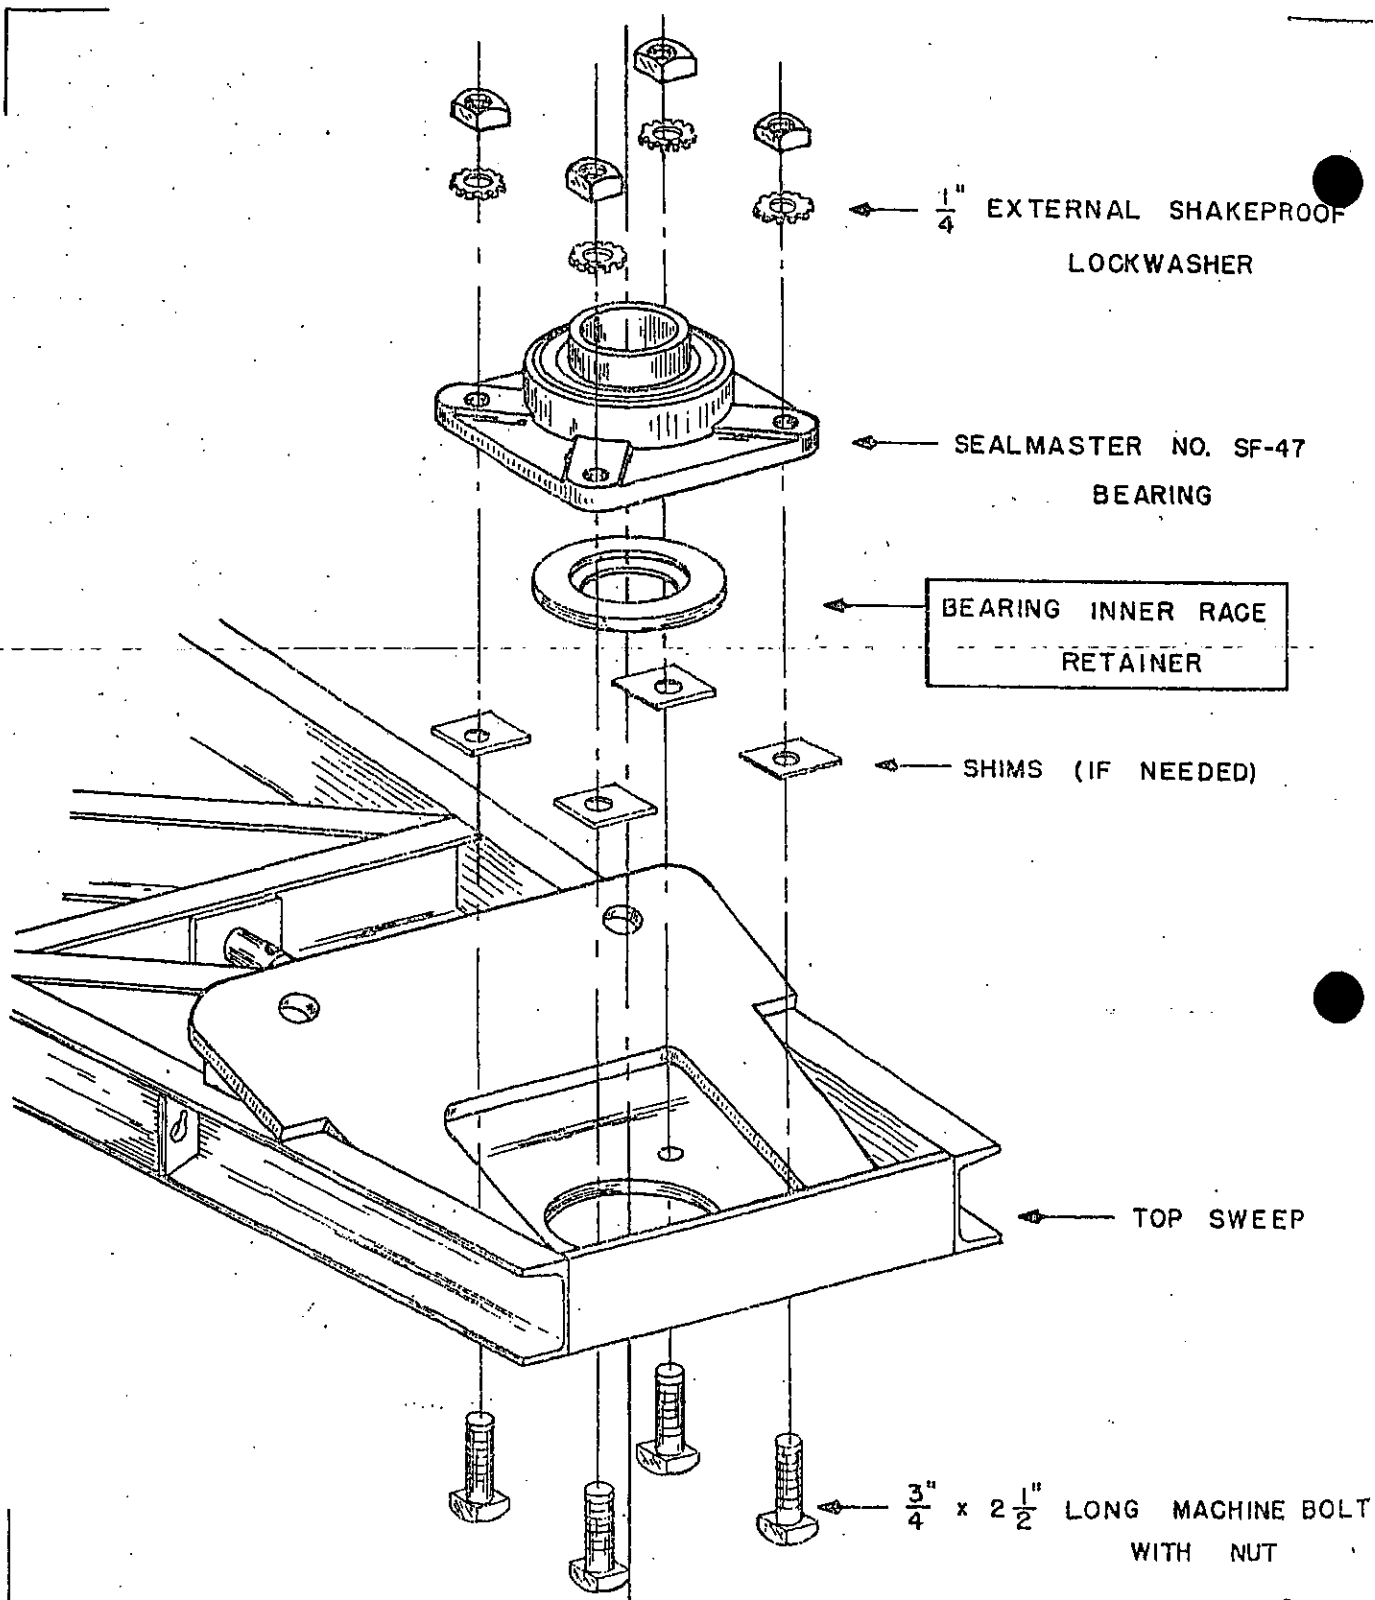
MODIFICATION OF SCRAMBLER TOP SWEEPS

In two instances it has been reported to Eli Bridge Company that the Sealmaster SF-47 flange bearing casting has failed, allowing the unit pole to drop through the opening in the top sweep. When this happens it can be a severe hazard to any passengers who may be riding at the time. Therefore Eli Bridge Company is making available the special bearing inner race retainer shown, as a safety measure. Remove the bearing on the top sweep, set in place the bearing inner race retainer with its biggest diameter on the top side, and then put down the bearing again. The bearing inner race retainer is a loose piece, and be sure that when you tighten down the bearing, the bearing inner race retainer is still loose. This will not interfere with normal procedure for assembling the unit pole to the top sweep, but will insure that if the bearing casting should fail, the unit pole will not drop to the ground.

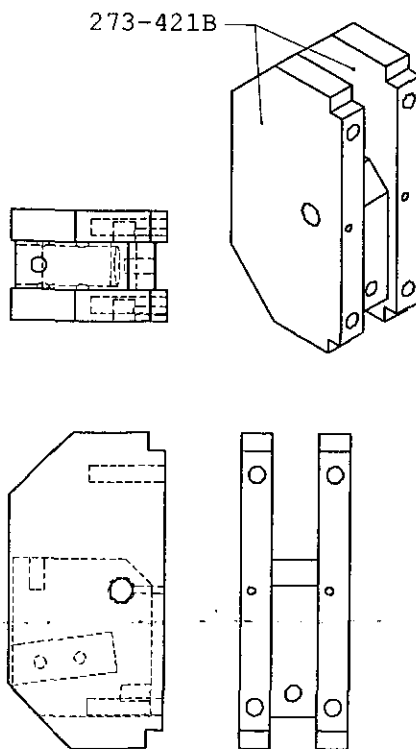
Reason For Release: It has been brought to our attention that it is possible to pinch fingers between the lap bar pivot block and the lap bar hinge blocks if care is not used.

Actions to be taken: Eli Bridge Co. has redesigned a wider lap bar hinge block that covers the sweep of the lap bar pivot block movement to minimize the possibility of pinching the fingers when raising or lowering the lap bar. The suggested replacement part # is 273-421B which consists of 4 lap bar hinge blocks that can be screwed to the existing door in place of the original block # 273-421A. All existing components are reused with the wider hinge blocks. Two 5/16 -18 x 3/4" long pan head screws (stainless steel) hold the hinge blocks to the handle bar.
