SERVICE LETTER 1

Subject FRISBEE Gondola Passenger Restraints (Shoulder Bars)

**Refurbishment Instruction for friction gear truss – Frisbee
Assemblies 29.009-1 and 29.009.E-1
Relating refurbishment drawing: 29.009.S-2**

Refurbishment Friction Gear
Drive - longitudinal section

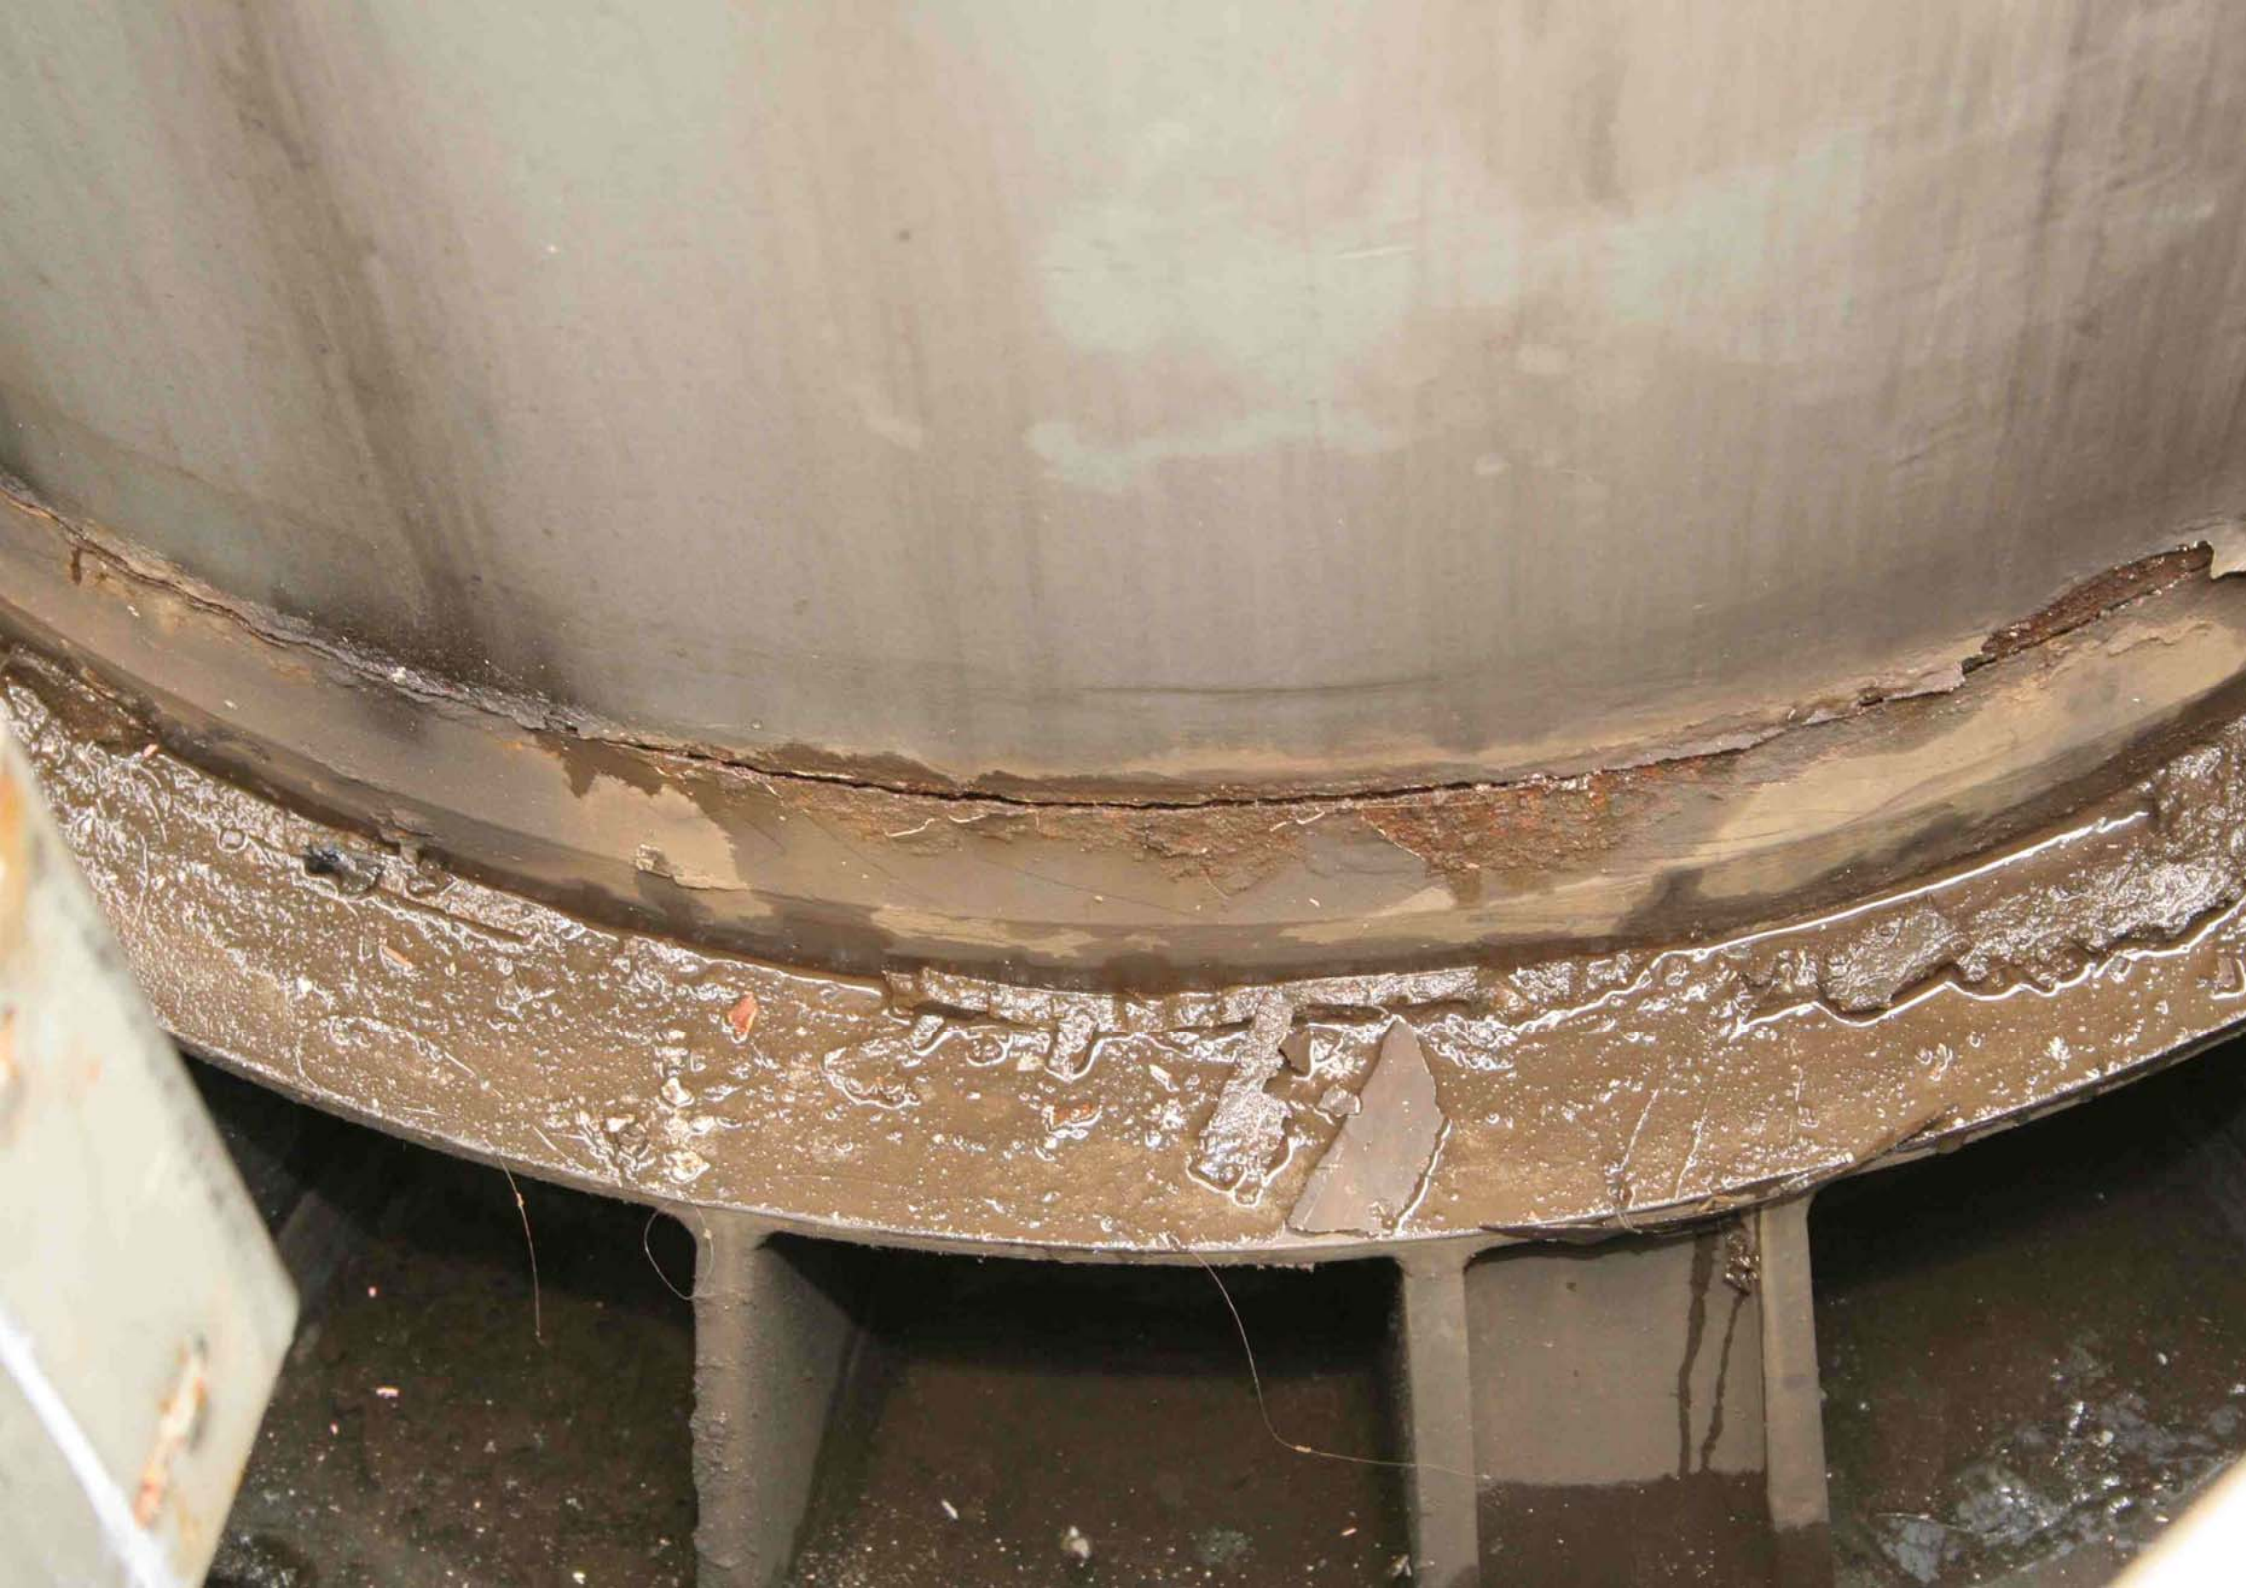
Basis for refurbishment is drawing no. 29.009.S-2. Damages might occur at two and/or three positions:

1. Crack in circulation direction inside the jacket plate (Pos. 1, 29.009.S-2), below the flange level (Pos. 4, 29.009.S-2).(marked with 11)
2. Crack at the edge of the seam between Pos. 5 and Pos. 4 outside the jacket plate (29.009.S-2) (marked with 12)
3. Crack in the seam between Pos. 5 and Pos. 1 (29.009.S-2) (marked with 13).

First, the crack under point 1 must be repaired. This must be worked out carefully, at least until a depth where the crack completely disappears. The assumed diffusion direction is going off beveled, possibly until the melting zone of the lower fillet weld between pos. 4 and Pos. 1. The adjacent interior faces of the jacket plate (Pos. 1) must be cleansed from rust and dirt. The welding is a continuous welding in several layers, whose surface must be finished evenly.

Secondly, the ring Pos. 5 must be deleted. For that purpose, the seams at the marks 12 and 13 must be abraded. At mark 12 it is a Half-V butt joint with not full cross-sections, i.e. dependant on the melting zone, a wedge-shaped countersinking with each 8-9 mm in the cross-section triangle blade would be sufficient (if not, the measurements of the countersinking shall be increased gradually until this part separates. Caution! The basic cross-section of Pos. 1 and 4 may – as far as possible – not be destroyed!) Afterwards, Pos. 5 must be cut at two areas in the reversed condition and deleted.

Now, the possible broadening of the cracks with marks 12 and/or 13 can be tested. Executing the refurbishment goes necessarily into the jacket plate until the end of the crack. The refilling refurbishment welding must recondition the basic cross-section thickness of Pos. 1 and 4. Furthermore, a fillet weld must be accomplished between Pos. 1 and Pos. 4. at the top around the released edge according to the drawing.

After the corrosion protection works only the upper closing plate must be welded into.

Recommendation for a better identification of crack distribution: during gouging the crack should be done with co/bow arc.
