SERVICE BULLETIN 89-1

SUPER LOOPS

SERVICE BULLETIN 89-2

SERVICE BULLETIN 89-4

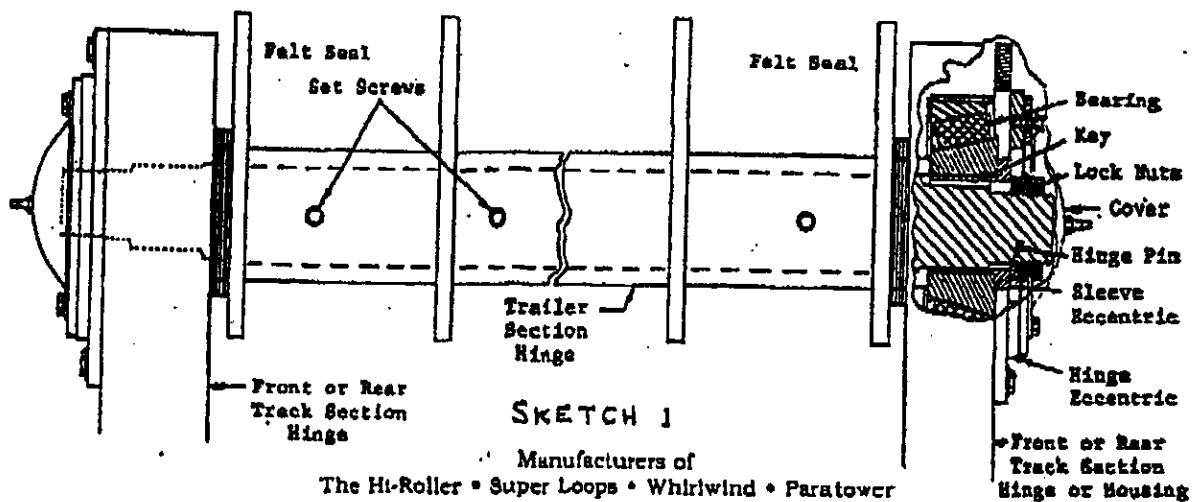
Fatigue cracks have been found in the hinge pins on some of the older Super Loops Amusement Rides. This fatigue could be caused by a number of factors. The two most obvious are: 1) the continual loading and unloading of the pin due to erection and lowering of the track and 2) improper support of the track during transport, allowing the hinge to take the majority of the bouncing load. With this in mind and in order to maintain a safe ride, the main hinge pins on the Super Loops must be inspected when the ride has been in operation for five (5) years and at five (5) year intervals thereafter. This inspection is to be a magnaflex inspection performed by an inspector certified in the use of magnaflex. Be sure and obtain a written copy of this inspection and keep it with your Super Loops manuals.

CAUTION: IT IS ABSOLUTELY necessary to replace the original or a new hinge pin in exactly the same position as the original pin was installed. If this is not done properly the track will not align and a very dangerous situation will be created.

Remove the cover from each end of the hinge. See Sketch 1. Mark the position of the hinge pin, sleeve eccentric, hinge eccentric, and the hinge housings. Mark both ends and use different markings on each end so that the parts will not get mixed. A number stamp works well so that each pin and each end of each pin will have a different number. These markings must be oriented so that the parts will be replaced in the same place and direction as their original position.

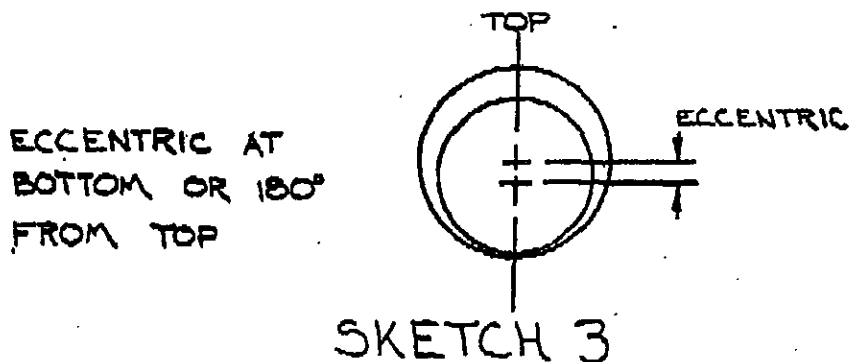
After the pin is removed, it must either be replaced or inspected by an inspector certified in the use of magniflux. The primary areas of inspection are the shoulders located near each end. This shoulder is the point where the shaft changed diameter from 2 7/16 inches to 3 inches. If there is evidence of a crack, the pin must be replaced.

To reuse a pin that has been found free of cracks, it must be remachined as shown in Sketch 2. This increases the corner radius, reducing the stress concentration of that area. Reuse of a pin without this change is not permitted.

If a new hinge pin(s) is ordered, place the old pin next to its replacement so that both are oriented the same. Mark the new one the same as the old. The three (3) set screws holes are not predrilled. This is to be done at assembly to insure proper position of the holes. Install the pin into the hinge housing. The pin should protrude equally out each end of the hinge housing. Align marks as previously set during disassembly. With the three setscrews removed, mark the positions of the setscrew holes on the hinge pin with a center or prick punch. Remove the pin and drill each center with a 21/32 inch diameter drill with the full diameter going 1/2 inch deep as shown in Sketch 2.

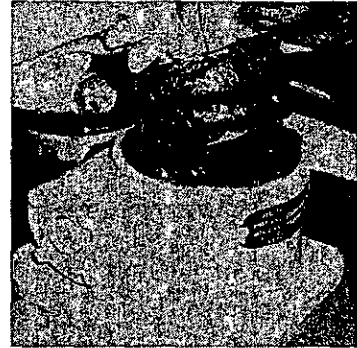
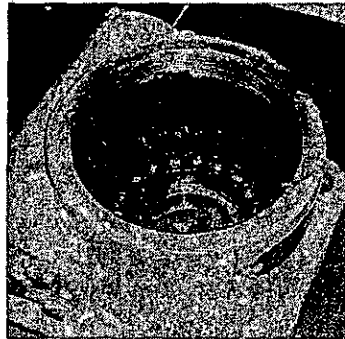
## STEP NINE

**WARNING:** Replace brass gear if threads are less than  $3/16''$ .

If brass gear threads are less than  $3/16''$ , install new brass gear. If threads are acceptable, reinstall.
