BULLETIN #6-133-MC

MAIN BOOM ROCKER SHAFT FOR ROUND-UP RIDES MANUFACTURED BY FRANK HUBERZ & CO., INC. AND KILINSKI MFG. CO.

BULLETIN: BU-135 MC

ANNUAL INSPECTION OF MAIN SPINDLE SHAFTS, ROCKER SHAFTS, CYLINDER ANCHOR SHAFTS

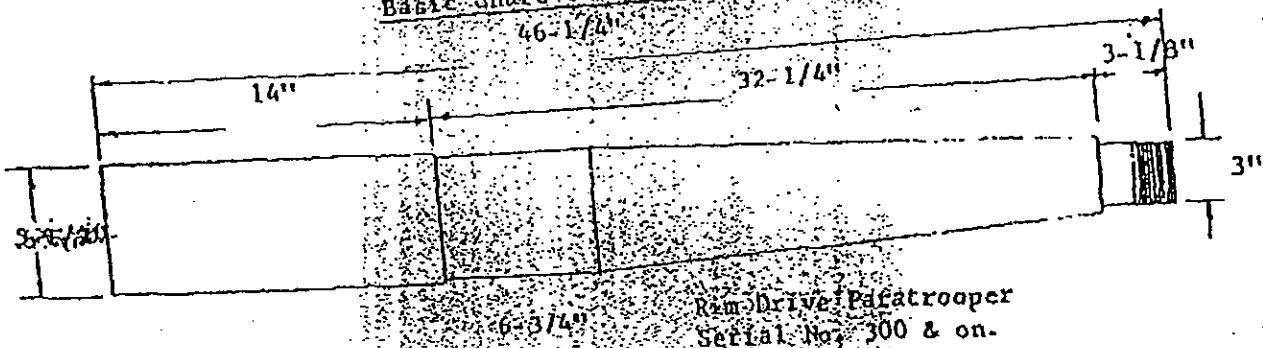
Basic Shaft Configuration

This test was performed on a Round-Up at Man-Co Mfg., Inc. by an independent testing lab. Using a 2.5 MHz transducer on the end of the shaft. The instrumentation was set up to produce a strong reflection from the opposite end of the shaft and calibrated so that the shoulder on the far end of the shaft registered approximately 15-20% of full scale. This would cause a crack at or near the closer shoulder to register significantly. The test was repeated at the other end of the shaft. A sketch of the shaft is on Sheet 2.

If you own a Round-Up, we strongly urge that you immediately inspect the main boom rocker shaft and the cylinder anchor shaft for cracks using Ultrasonic test. The test must be done by someone qualified to Level 2 ultrasonic testing. It is not necessary to disassemble the ride to perform the test on the main boom rocker shaft, or the cylinder anchor shaft.

THIS ULTRASONIC TEST MUST BE PERFORMED ANNUALLY.
