## SERVICE BULLETIN

To  
Fax  
Company  
Subject: MaxFlight Safety Service Bulletin 2008-001  
Sent: 4/13/08 at 8:30:00 PM

Units Affected: All MaxFlight Simulators [VR2000, VR2002, VR2500 and MT3000]

Purpose: To ensure security of both Pitch and Roll Encoders

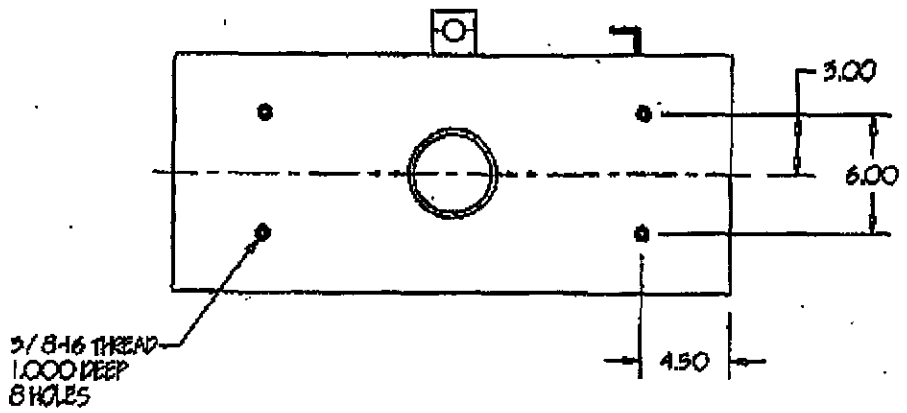
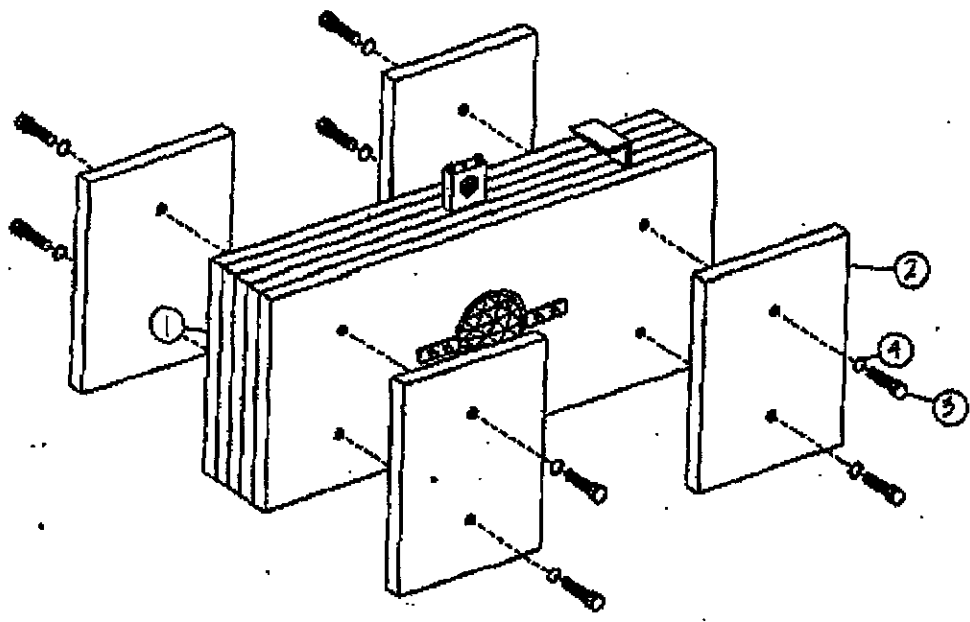
Title: Carterweight Add On Plate Assembly

> The attachment is of a Counterweight add on plate assembly for the  
 > MaxFlight VR 2002 (all VR 2000 series). While inspecting a VR20002 at  
 > Funscape in Ft. Lauderdale I found the above modification was  
 > attempted. Funscape had only attached two counterweight add on plates  
 > and they were only attached with one screw for each plate. I spoke with  
 > a tech from MaxFlight and was told that all four counterweigh add on  
 > plates had to be installed at per the attached drawing ie. two bolts  
 > with lock washer for each plate. It seems that Funscape, while trying to  
 > remove the old bolts, broke the bolts off and did not finish removing  
 > them. They replaced the bolts with the new ones where they could.

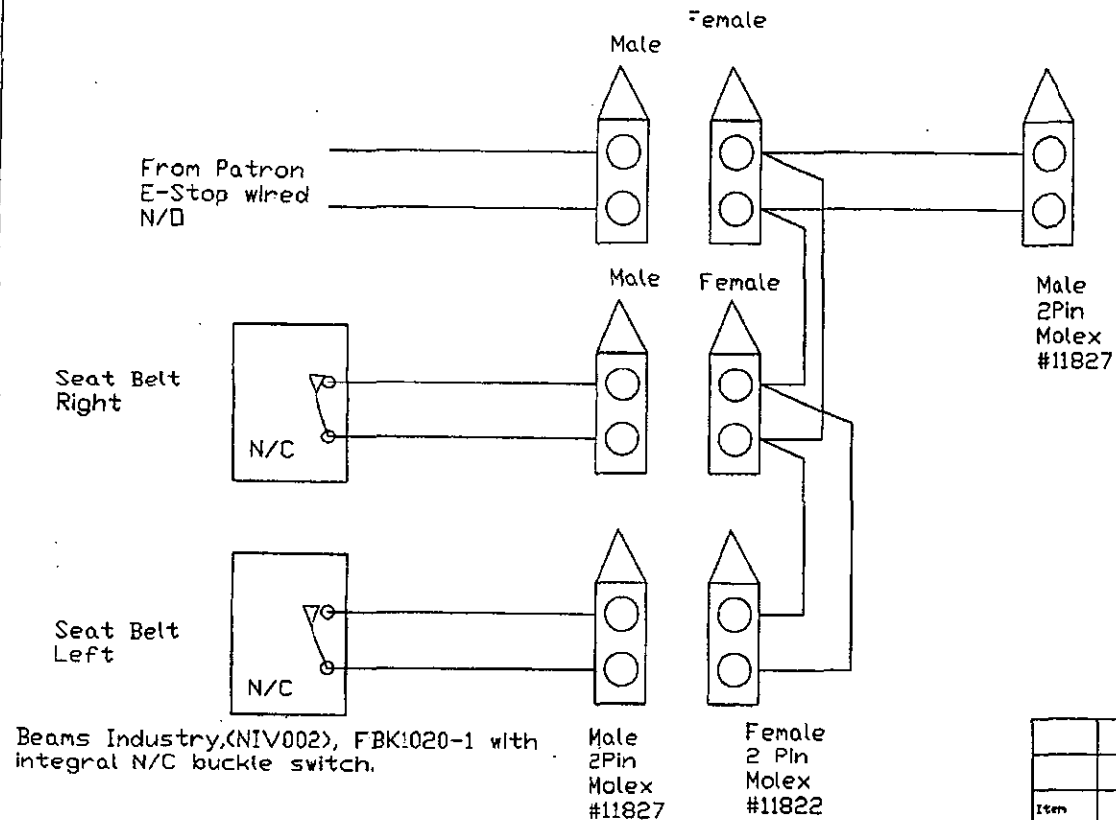
Item	Qty	Description (Part Number)
Parts List		
TITLE: Seat Belt Interlock Upgrade Elect.		
MAXFLIGHT CORPORATION 1 Executive Drive Toms River, NJ 08755 1-732-281-2007 FAX: 1-732-281-0209		
P.J.	DWG: SE11103	
Scale: None	DRAWN BY: VVB	
Matl:	DATE: 29 Nov 2004	REV
APPROVED BY:		DATE:

Upgrade diagram for Electric  
Machine Installing new sensor  
shoulder restraint crotch belt.

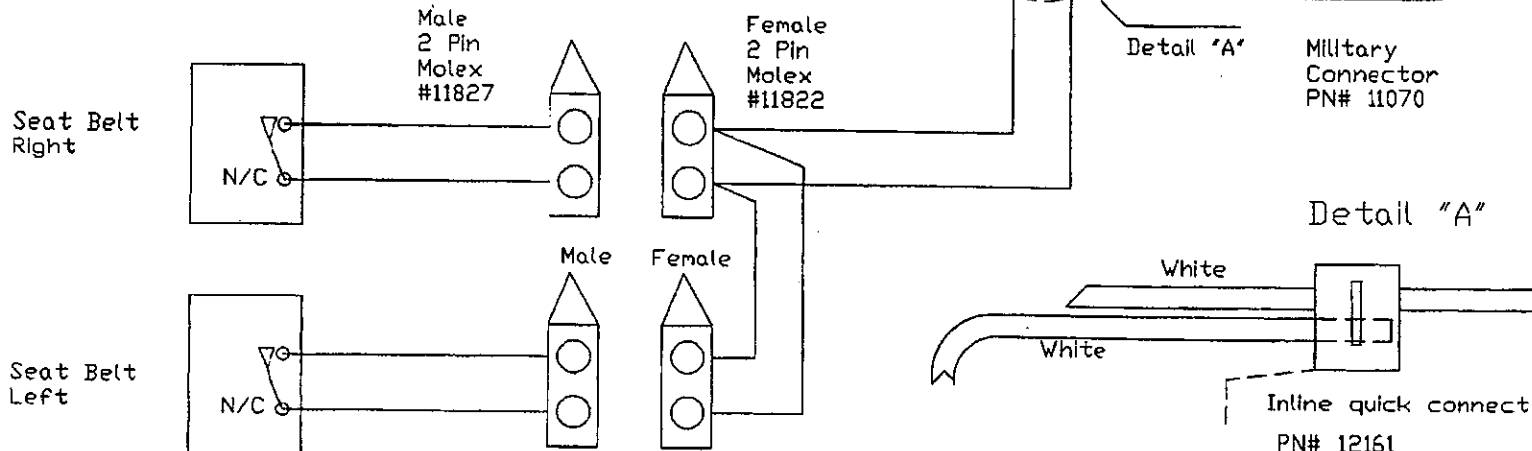
Item	Qty.	Description (Part Number)
Parts List		
TITLE: Seat Belt Interlock Upgrade Hydraulic		
MAXFLIGHT CORPORATION 1 Executive Drive Tom's River, NJ 08755 1-732-281-2007 FAX: 1-732-281-02009		
P.R.	DWG#	SE11104
Scale: None	DRAWN BY:	VWB
Mat#	DATE:	29 Nov 2004
APPROVED BY:	DATE:

Upgrade diagram for Hydraulic  
Machine installing new sensor  
shoulder restraint crotch belt.
