SORIANI srl

Bulletin No: 2004 TF02

SERVICE BULLETIN

Ride Name: Turbo Force and Stratosphere

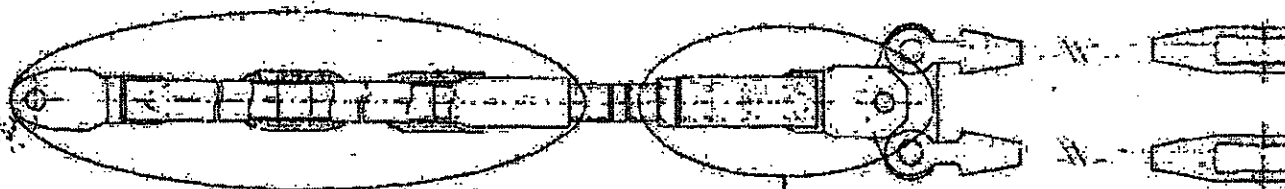
OLD

NEW

Install the new components on the support tubes as indicated on the attached drawings.

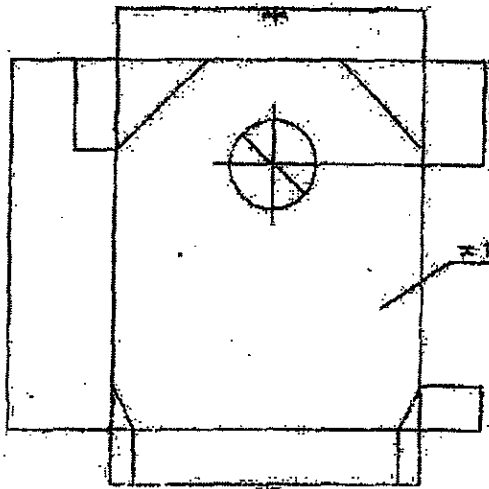
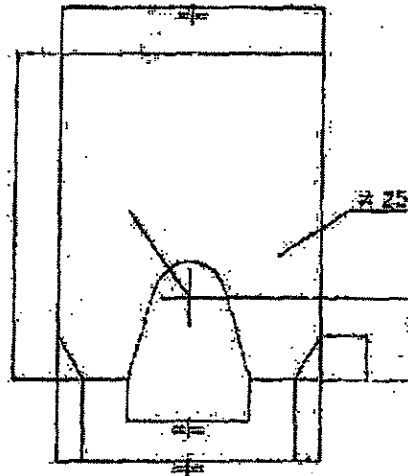
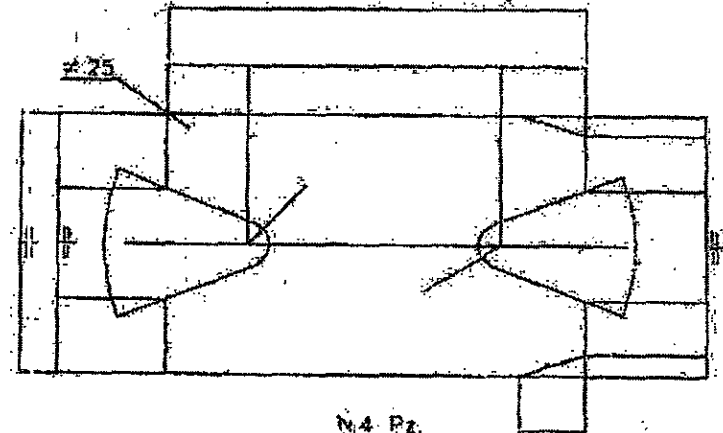
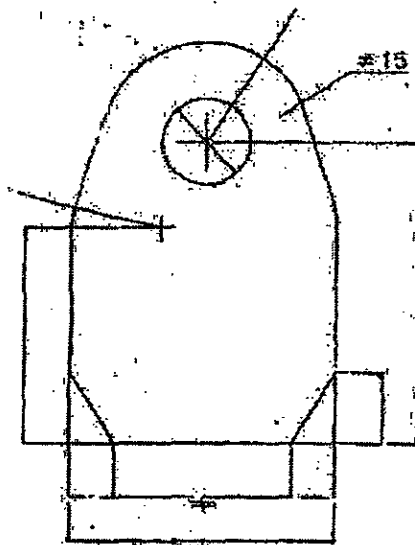
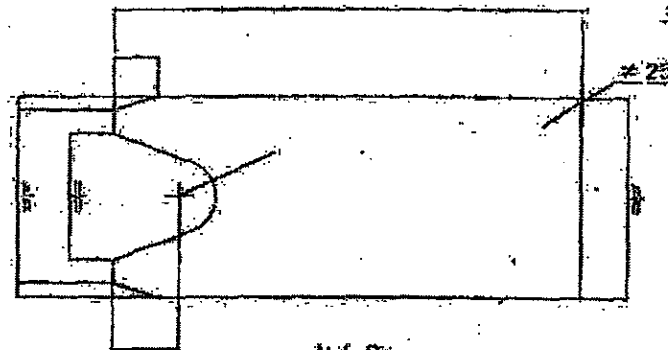
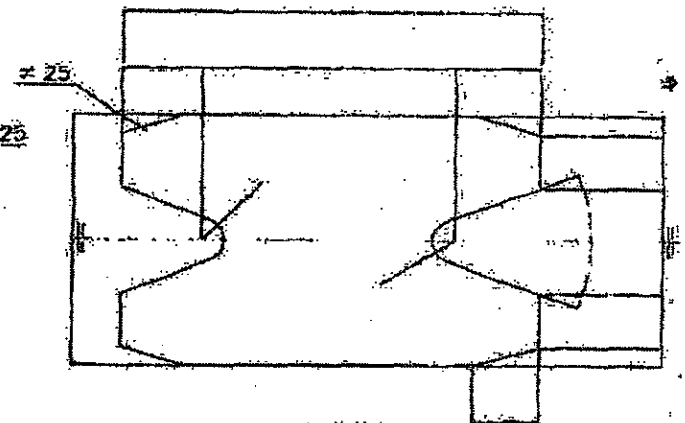
ULTRASUONARE

The notch in the pipe to for the 25 mm steel plates must be machined and have a chamfer along its sides and ends to accommodate the weld bead. The steel plate must be welded to the pipe all around, which is recommended by the DIN Standard 15018, on table 31, notch case K3, code 342 and code 343. The slot in the pipe will accommodate a plate with angled ends, which is welded with a single bevel butt weld with fillet weld. The weld is then machined across the end and 125mm back along each side, starting at the end to avoid notch effect. (DIN 15018 is the reference standard for the design and calculation of the Turbo Force). After welding and machining the weld is to be inspected by magnetic particle. See following diagram and drawing:
