**REVERCHON, S.A. INDUSTRIES, FRANCE
"HIMALAYA"
April 22, 1998**

AMUSEMENT RIDE SAFETY ALERT

Subject : Repair of « HIMALAYA » amusement ride

CPSC, Reverchon Industries Announce Repair Program for Himalaya Amusement Rides

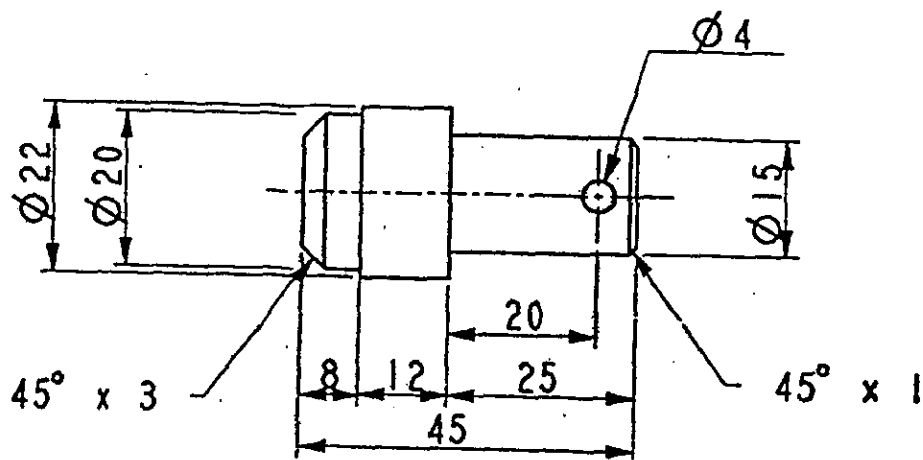
Need to replace

To replace the 2 inferior axles maintaining the bar (see photo hereafter) by one axle which is designed on drawing number 40-6191-42 A- Insert.
