# Tivoli MFG Ltd.

## Service Bulletin

Bulletin No: SOSR001

Ride Type: Spin Out  
Date: September 8, 1998

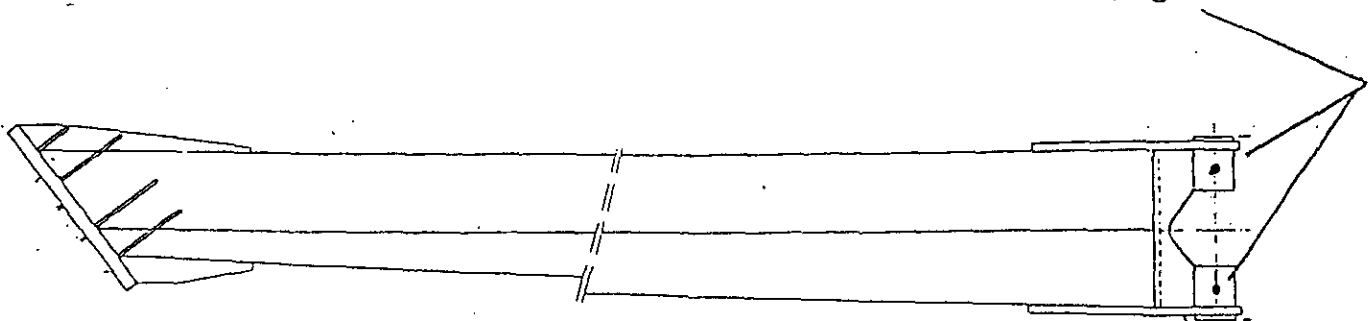
Fig. 1

Locate Grease Fittings

1. With both pins installed in sweep, Remove the threaded collar from the bottom of the pin below the sweep hub. This requires the removal of a set screw locking the collar to the threads.
2. With the other pin slightly loosend, remove hing pin by tapping out with hammer and brass or alluminum rod.
3. After pin is removed drill a 3/16" hole through the center of the sweep bushing collar so the hole comes through between the two internal bushings.
4. After all 3/16" holes are drilled 2 per sweep, 8 total, counter bore a 21/64 hole approximately 10mm deep ( 3/8" ). As in step 1 use a shop vac to collect filings while drilling.
5. Tap counter bore with a 1/8" pipe tap, Clean toughly.

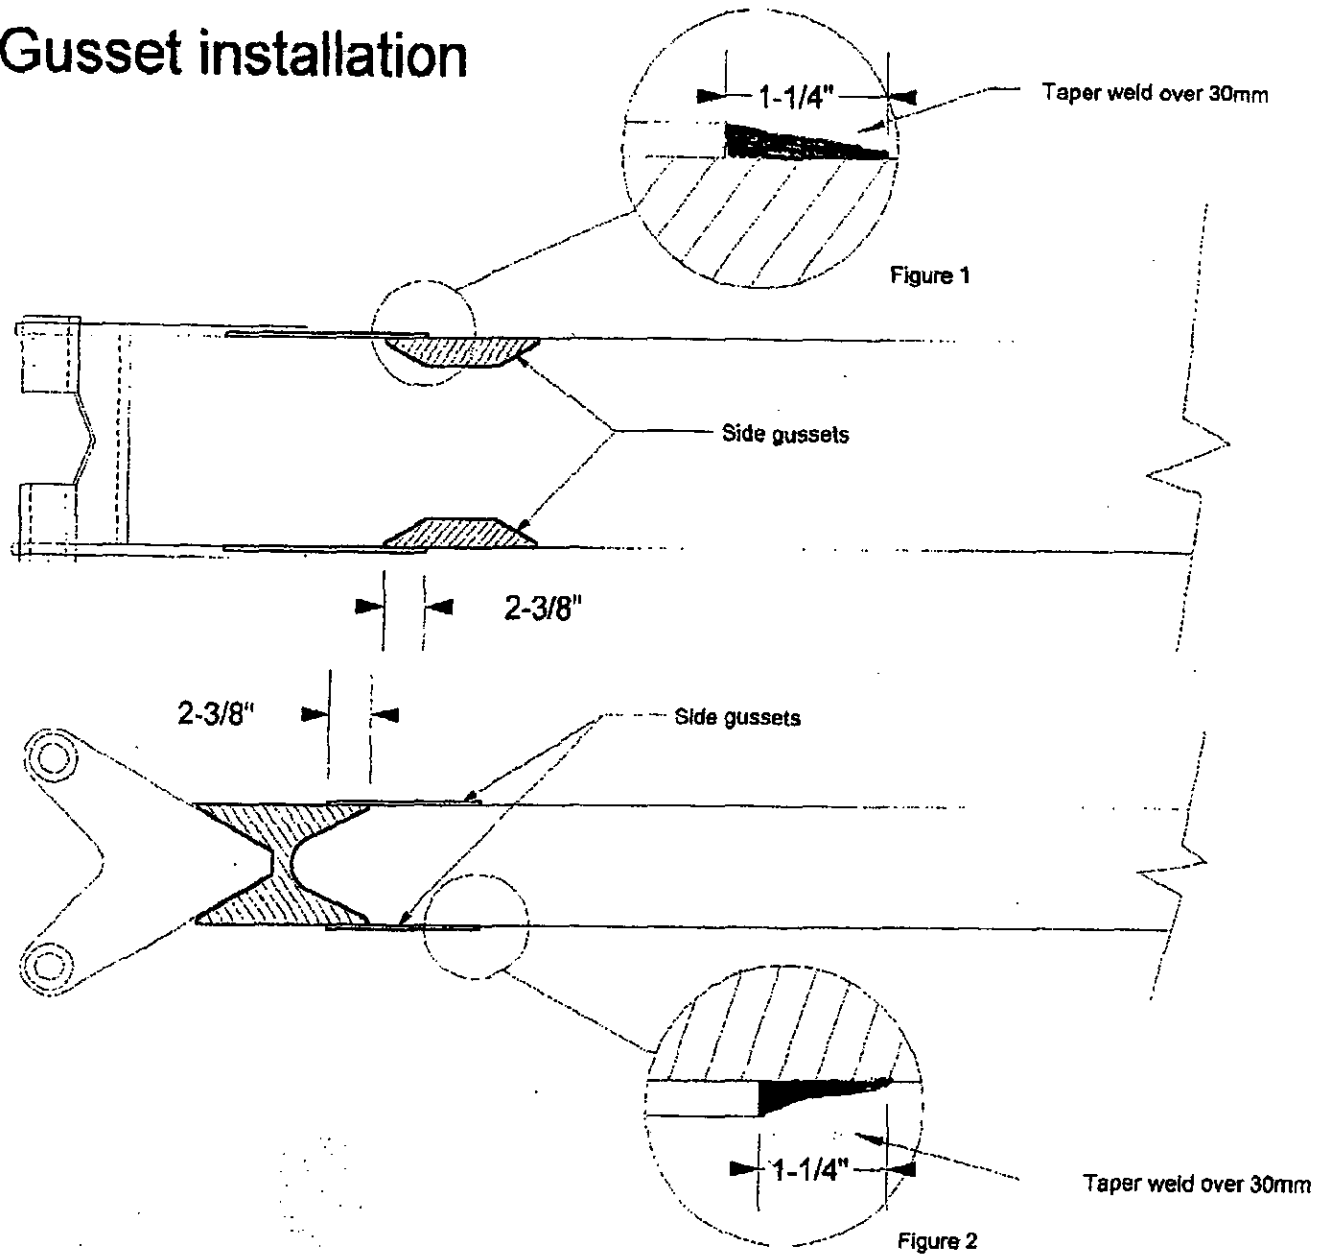
# Side Gusset installation

**Purpose:** Sweep Arm Cracking

- Step 19: Taper weld from side point of top plate to side gusset as described in figure 1 drawing SOSA010E.
- Step 20: Taper weld at end of side gusset as described in figure 2 drawing SOSA010E.
- Step 21: Dress and sand all welds.
- Step 22: After all work is completed, paint sweeps, reassemble ride and completely inspect and test as outlined in the operators manual before opening to public.
