Bulletin No.:	HL19103140
Release Date:	12/3/2019
Effective Date:	IMMEDIATE
Supercedes:	HL19021240
Completion Date:	Opening 2021
	(will vary)
Page:	1 of 4

SERVICE BULLETIN

Ride Manufacturer:	Great Coasters Int., Inc.	Affected Production Dates:	All
Ride Name:	Varies	Affected Serial Nos.:	N/A
Model Number:	All GCII Rides with Millennium Flyer trains

Abstract of Issue:

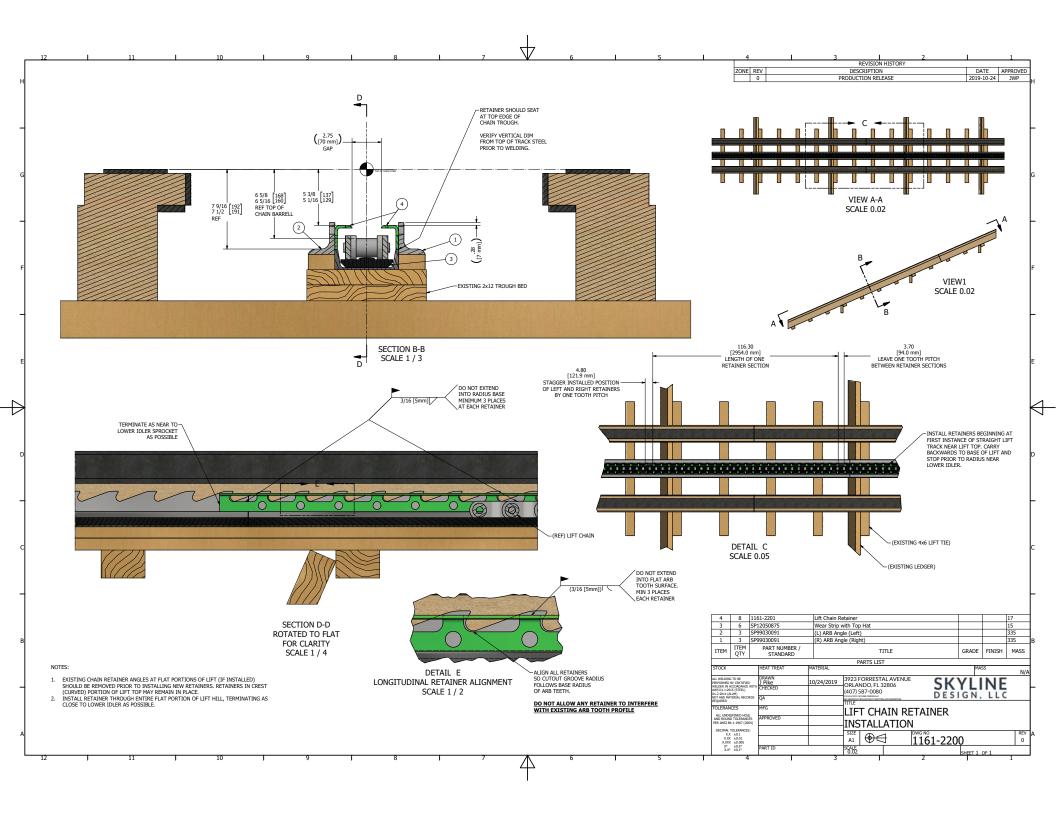
Like the current retainer angles, the new chain retainer is installed via welds to the ARB angle. However, the major difference is that the new design provides continuous coverage along the entire length of the chain trough. Refer to Figures 1 and 2. This reduces the risk of the chain leaving the trough, and directs the broken chain down the trough to gather near the motor base or the lower idler.

The newly-designed Lift Chain Retainer (1161-2201) must replace the existing chain retainer angles (SP07060442) along the flat portion of the entire lift hill. This requires that the current chain retainer angles be removed before the installation of the new retainer. Please refer to Note 1 on the included installation drawing for more details.

- A revised Lift Chain Retainer (1161-2201) must be installed in accordance with the included drawing (1161-2200).
- Modified Chain Dog Mount Weldments (98083005L) must be installed on all Millennium Flyer trains.
- Inspection of the chain **must be added to your end-of-season checklist** and performed according to the updated chain wear section of this bulletin.
