NUMBER: B408R1182-0

## SERVICE BULLETIN

Ride: CHAOS

Subject: Latching Rod Rework

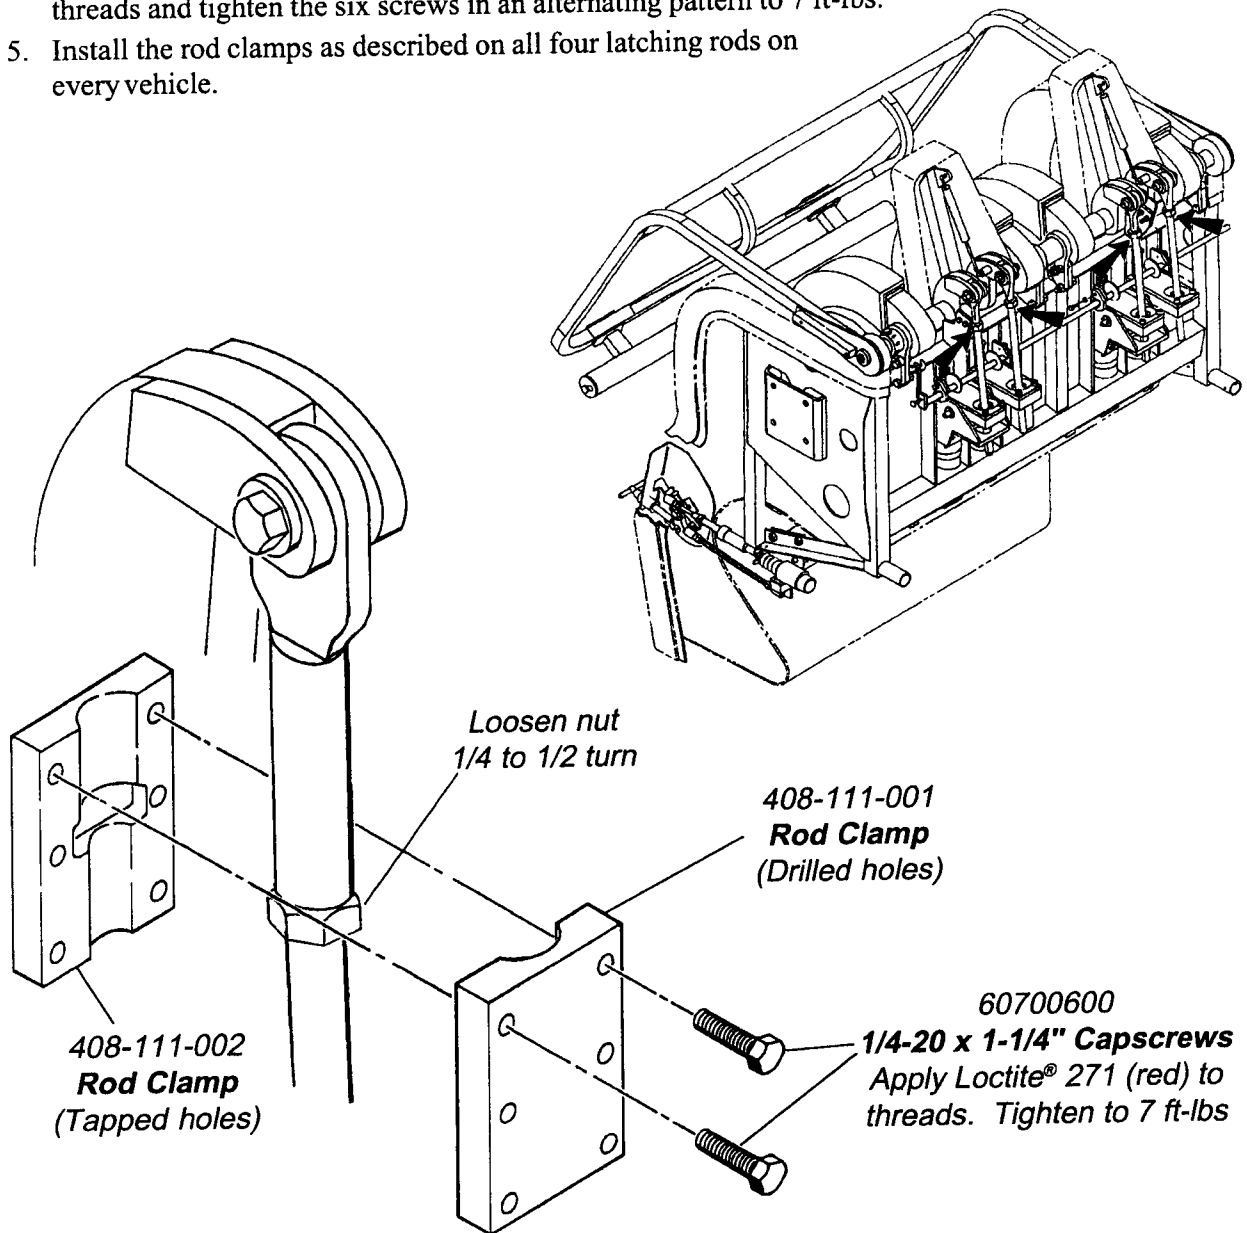
1. Remove the back cover from the vehicles. Locate the four latching rods, indicated by arrows in the following illustration.
2. Loosen the four nuts  $1/4$  to  $1/2$  turn.
3. Install one **Rod Clamp with tapped holes** and one **Rod Clamp with drilled holes** over each of the four latching rods.

**IMPORTANT:** Each rod clamp has recessed areas to mate with the latching rod, rod end and jam nut. All parts must be installed correctly to function properly. Be sure the large radius recess is at the top, to mate with the rod end.

4. Secure the rod clamps with six  $1/4$ -20 x 1- $1/4$ " Capscrews provided. Apply Loctite® 271 to the threads and tighten the six screws in an alternating pattern to 7 ft-lbs.
5. Install the rod clamps as described on all four latching rods on every vehicle.
