Dartron Salem, Oregon 97309 Issuing Entity:
Dartron Industries, Inc

Bulletin # PI-04020K-02

PRODUCT IMPROVEMENT

Ride Manufacturer:	Dartron Industries, Inc.	Affected Production Dates:	All
Ride Name: Cliff Hanger		Affected Serial #'s	All
Model # All

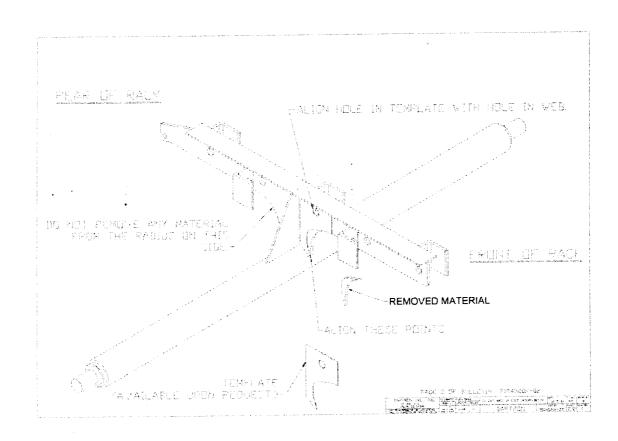
Abstract of Issue: Dartron has designed a more robust car hanger for the Cliff Hanger ride. The more robust car hanger locates the gussets on the front and rear faces of the square and round tubes. At one location in the car transport rack this gusset configuration creates an interference with the car transport rack. The only location where this interference is experienced is the third position in on both the driver and passenger side car transport racks. To be able to transport the more robust car hanger in the third position in either transport rack a modification must be made to the rack.

- 1. Dartron will provide a template to be used to identify the material that should be removed from the car transport rack.
- 2. Place the template on the web of a transport rack. See Page two.
- 3. Align the hole in the template with the hole in the web and align the bottom point of the template with the similar point on the web. See Page two.
- 4. Mark the material to be removed.
- 5. Material can be removed by use of a grinder or by either an Oxygen Acetylene or Plasma arch cutting system.
- 6. The edge that is cut must be ground or sanded smooth to remove any slag or gouging from the cutting process.
- 7. A clean smooth surface of the cut area is essential to avoid stress risers that, over time, could result in cracking.
